Energy Conservation Project Commissioning Report

City of Guelph Material Recovery Facility

Rose Technology Inc.
5525 Eglinton Avenue West, Suite 100
Toronto, Ontario, M9C 5K5

February 9th, 2012

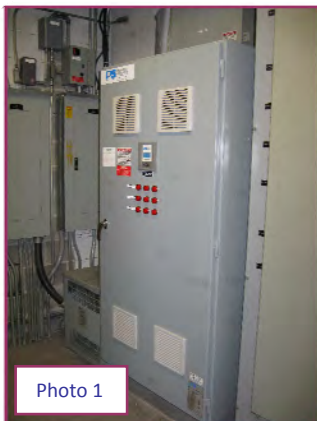
Rose Technology installed a 250 kVAR, 600-volt automatic harmonically filtered capacitor bank on the existing housekeeping pad to the left of the main service board next to the 1,500 main service board (Photo 1) and the interior view of unit (Photo 2) with capacitor banks (silver cans) at bottom of photo, filter units (coils) seen in the middle of photo and automatic switching contact circuitry and fusing just behind and above filter units.

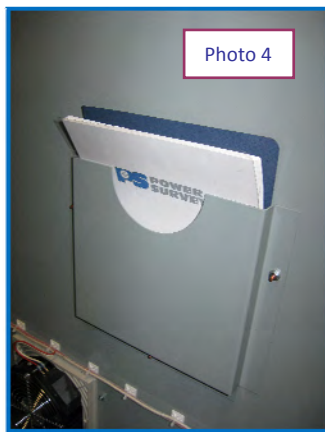
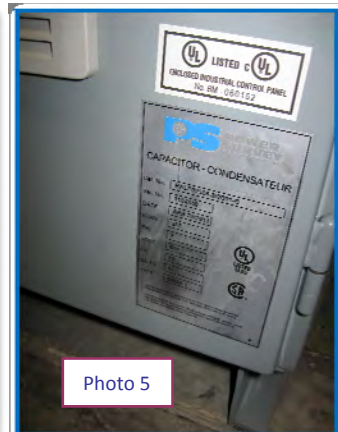
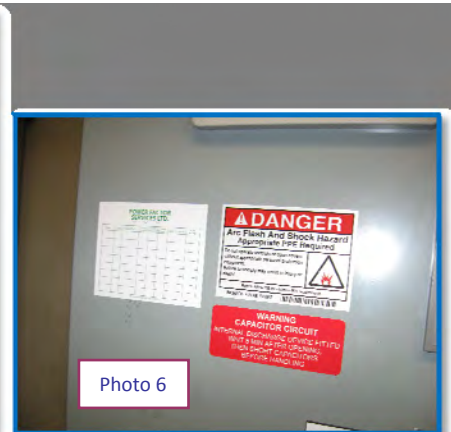
Commissioning inspection also included review of equipment documentation, equipment nameplate data and warning label and was found to conform to manufacturer equipment specifications and with Rose Technology's design specifications (Photos 4, 5 and 6).

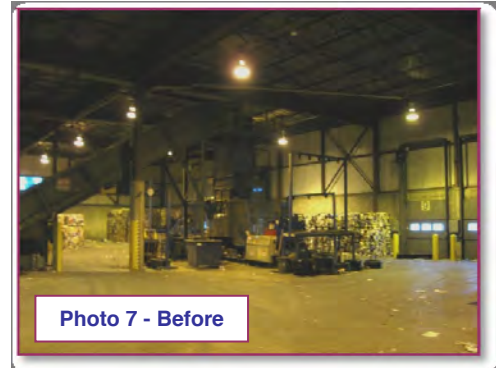
The majority of the Material Recovery Facility (MRF) operation was lit with 400 watt High Pressure Sodium (HPS) industrial high-bay fixtures together with a small numbers of 250 watt HPS low-bay fixtures. The HPS fixtures were suspended from the open ceiling structure above the bailing equipment and bail storage sections and over the process conveyor section of the MRF. High Pressure Sodium light sources produced a golden-yellow monochromatic light which appeared dim in comparison to other white-light sources due to their poor colour rendering index characteristics of 20 to 22 CRI (see Photo 7).

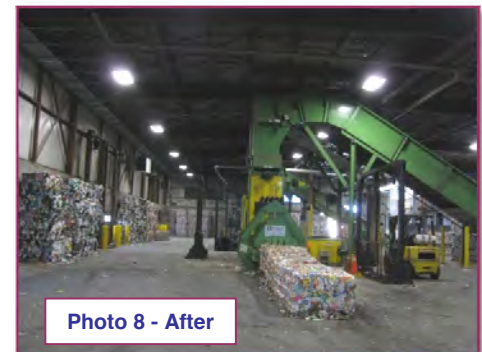
Rose proposed and implemented with MRF maintenance staff a lighting redesign of existing HPS lighting; by replacing the existing 400 watt HPS industrial high-bay fixtures with new six-lamp T5HO enclosed High-Output fluorescent high-bays and by replacing existing 250 watt HPS low-bay fixtures with 2-lamp enclosed vapour-tight luminaires (see Photo 8).

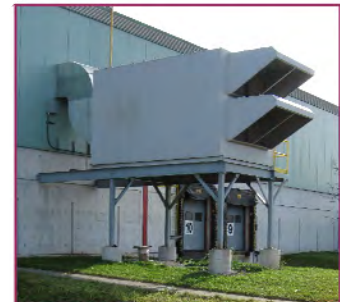
The BAS system had been configured with trend logs to monitor key system parameters. In reviewing the trend logs, we can see the unit is operating as designed. The trend data for the operation of MUA 2/1 is shown below, for the week of January 4-10.

It is noted that the MUA unit is now operating on schedule between the hours of 7:00 AM and 6:00 PM; whereas before the unit ran continuously. The operation of MUA Unit #2/2 is comparable to MUA Unit #2/1, and for brevity has not been included in this report.

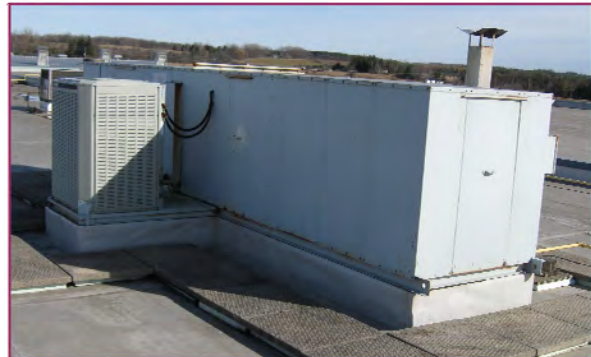
Rooftop Units: The seven rooftop packaged units, which provide both heating and cooling to offices and rooms in the tipping and bailing areas, are now controlled on the BAS. The programming will automatically switch from cooling to heating (a function that was manually controlled before retrofit) and will operate the units to maintain the space temperature between setpoints during occupied and unoccupied periods. The scheduling of these units has been setback during unoccupied periods. The BAS system has the functionality to override this setback with a push button located in each of the zones.

As with the MUA units, the RTUs have been configured with digital trend logs to monitor key system parameters. The trend data for the operation of RTU 3/2 is shown below, for the day of January 10, 2012. Along with the fan operation, the BAS monitors supply air temperature, outside air temperature, heating call, cooling call, fan status, and filter status. Due to the amount of data available, only one day of fan operation is included, which shows compliance with the provided schedule.

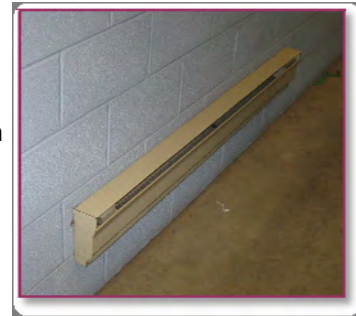
Baseboard heaters: There are a number of electric baseboard heaters installed in the MRF, specifically in the mens's and women's bathroom, the hallway and in the lunch room. Before the BAS retrofit, these heaters operated with a line voltage thermostat, with not setpoint control or setback ability. The BAS system installed now controls the operation of these baseboard heaters. The temperature setpoint has been limited to 69F with a night setback of 50F. This control strategy eliminates unnecessary operation.

The washroom exhaust fan works in conjunction with the electric baseboard heaters. The BAS system enables or disables these fans based on the building master schedule. This saves electrical power when the fan is disabled, and electrical power from the electric heaters that no longer have to heat up cold makeup air.
