**The Regional Municipality of Durham**

**Recycling Facility**

**MRF Processing Equipment Condition Assessment**

**CIF Project # 336**

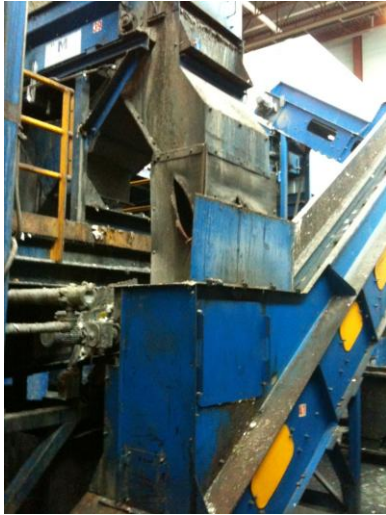
Torn rubber discharge chute from C-39 heavy's conveyor.

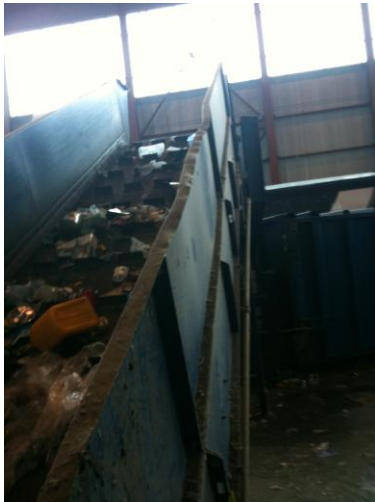
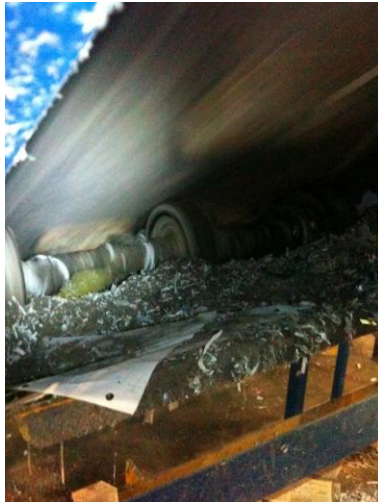
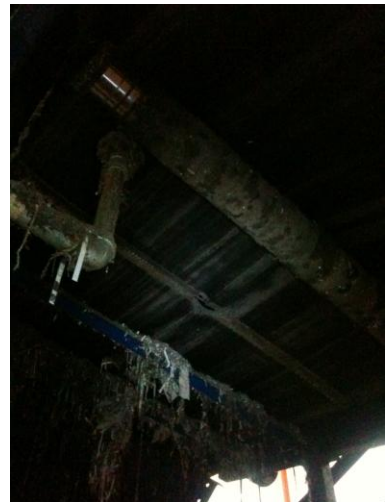
C-24 Residue compactor feed conveyor; bent side skirt, debris build-up, damaged belt splice and debris build-up on the return idler and sprinkler head.

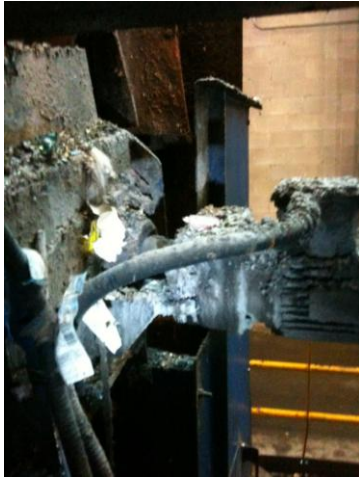
Build-up on C-40 heavy's conveyor.

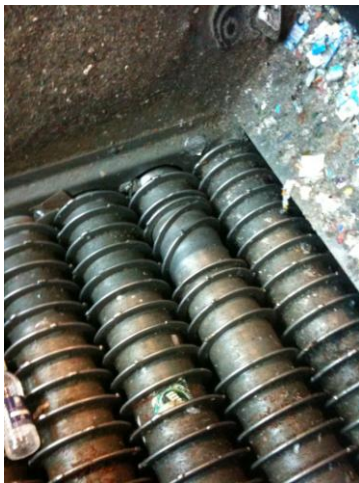
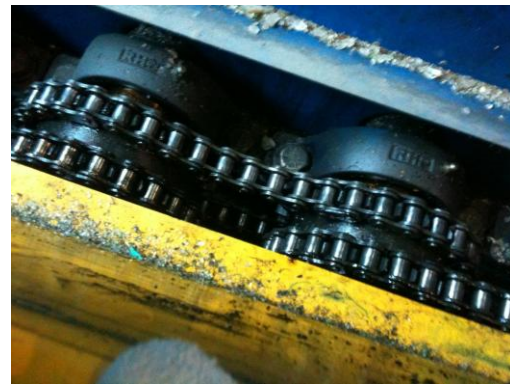
Broken Discs and slack drive chain on S-37 fines screen.

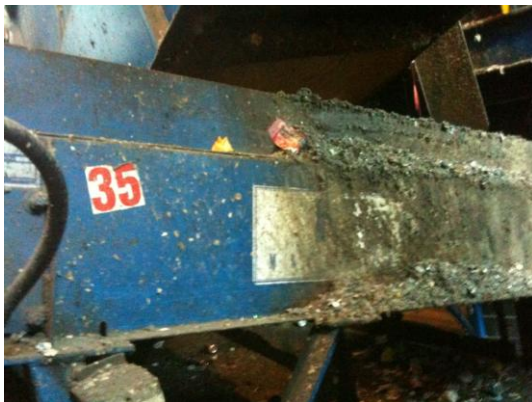
Debris build-up on C-35 transfer conveyor.

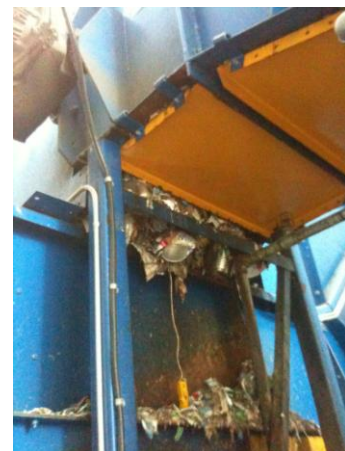
Debris Build-up under C-31 head shaft.

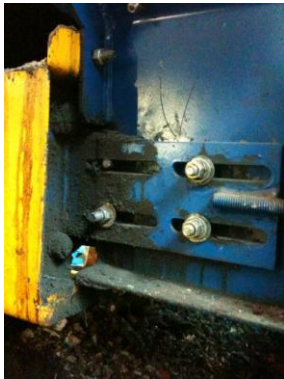
Broken mounting stud on C-51 tail shaft adjuster bracket.

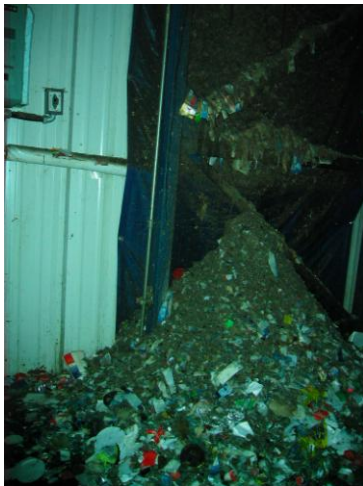
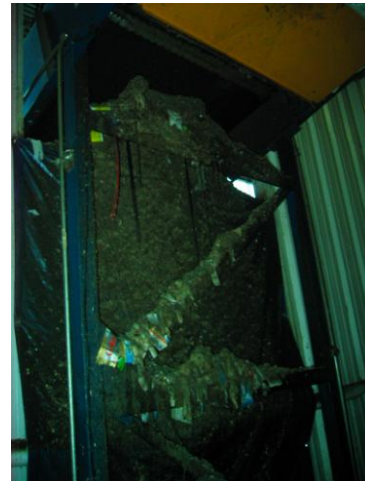
Excessive debris build-up under C-46 transfer conveyor in plastic's sorting room.

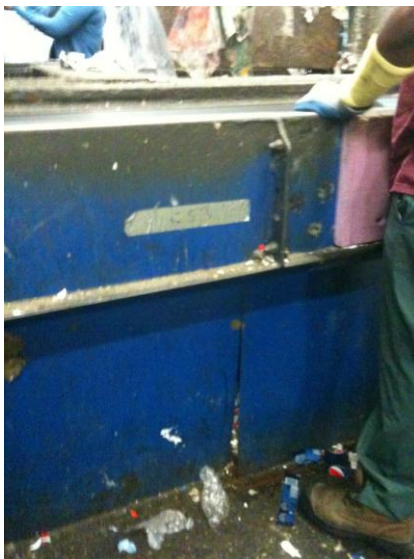
Debris build-up trapped under the fixed conveyor guards of C-48.

This is typical of the other 3 optical sorter post-sort conveyors.

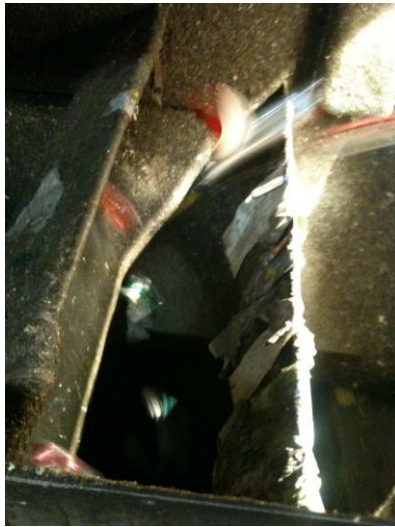
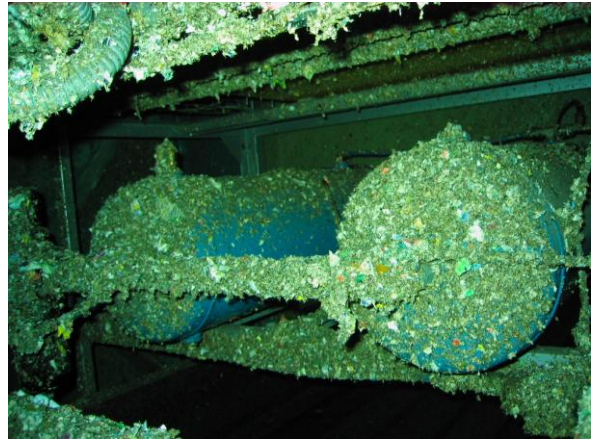
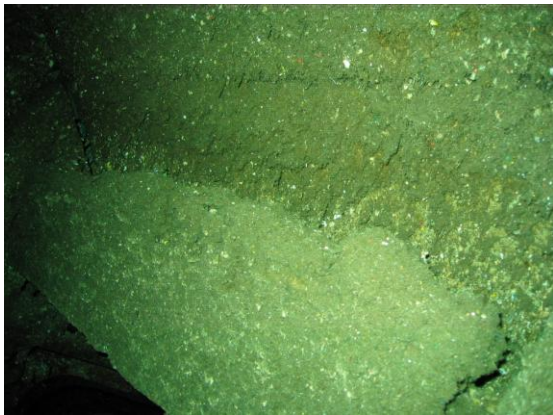
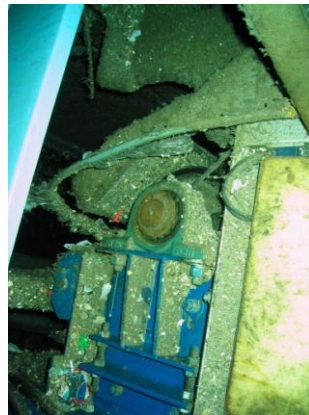
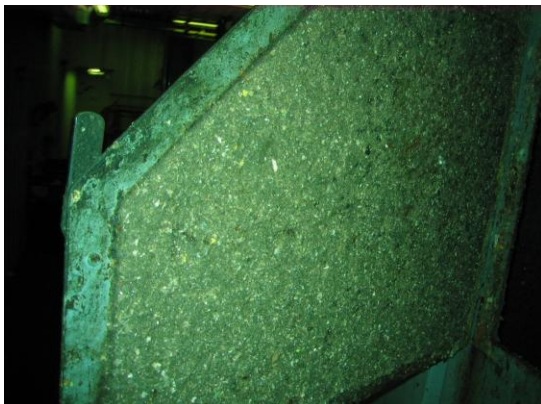
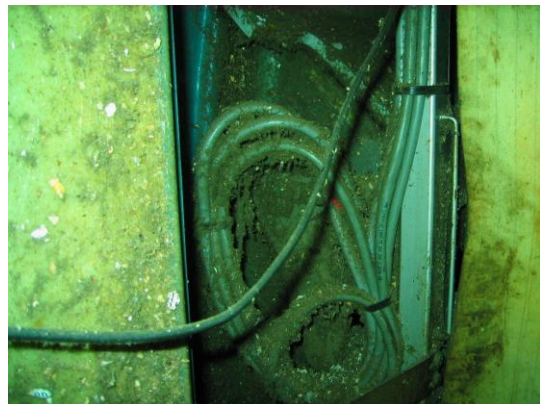
Excessive debris build-up in all areas of the optical sorters.

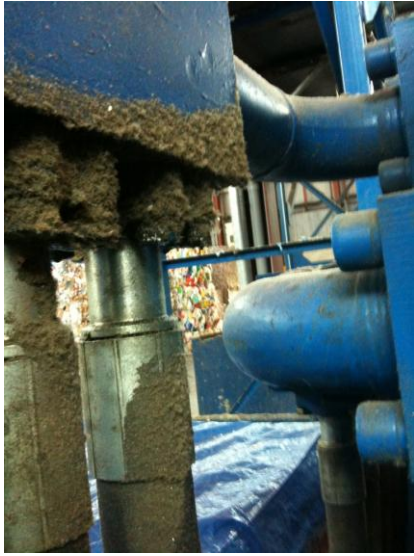
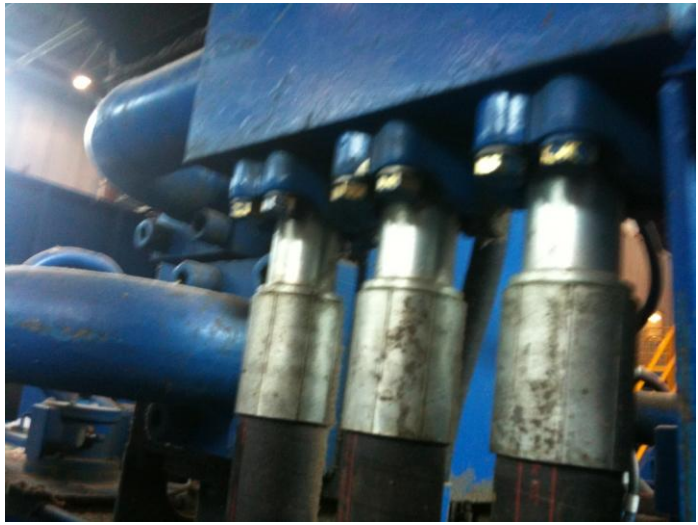
Note the possible oil leak on the hydraulic hose manifold on the 2 ram baler. Note comparison of wet & dry parts of the manifold shown above.

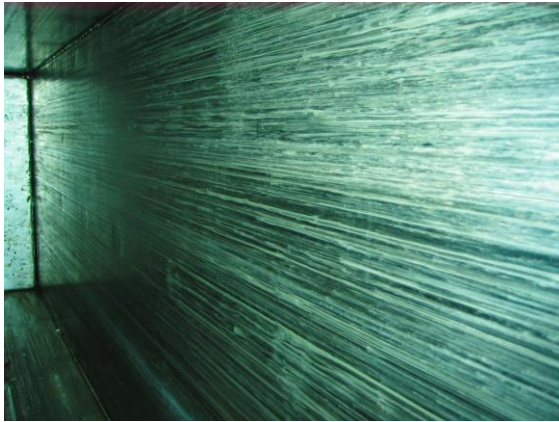
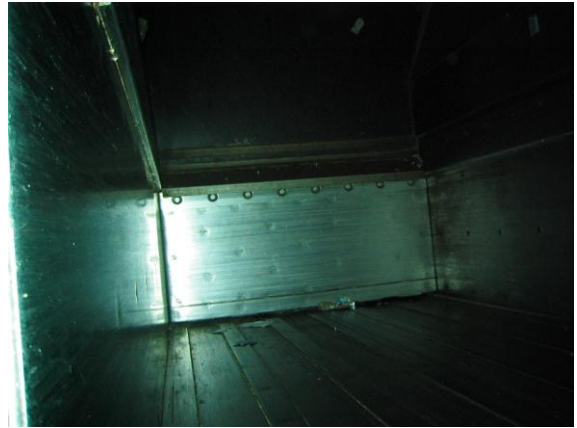
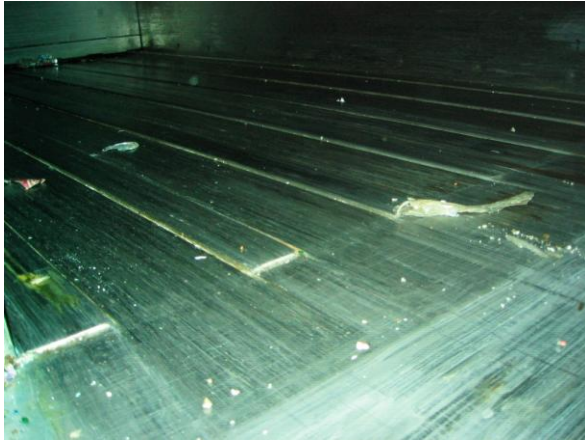
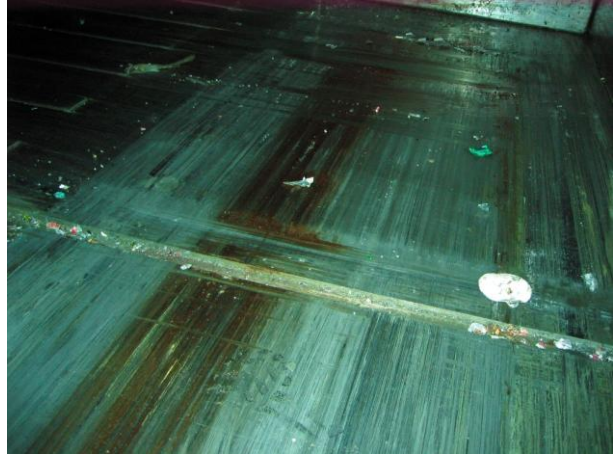
The photos shown above illustrate some of the areas of excessive debris build-up and the wear in the Harris 2 Ram baler chamber.

Normal wear inside the bale chamber on the floor and side walls.
