Final Report

CIF 124: City of Stratford Multi-residential Program Enhancement Project

Prepared by: 2cg Waste Management Consulting Services

Date: February 2011 Submitted by: City of Stratford

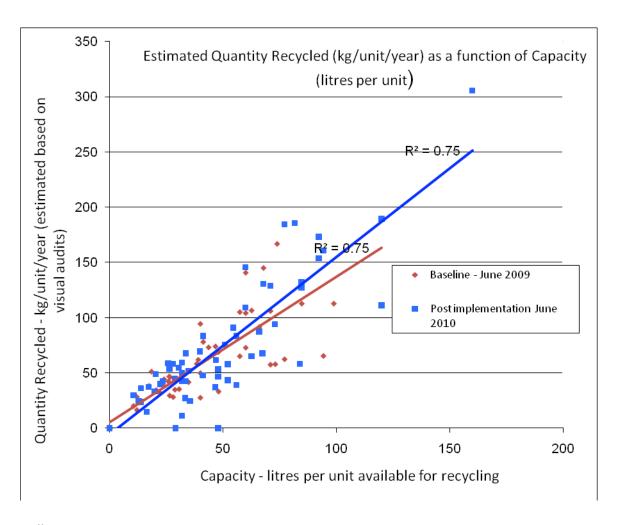
The main project enhancements were: increase the number of recycling carts, provide in-unit containers to residents, and provide P&E printed materials to residents. Graph 1, below illustrates a strong correlation between the number of carts (capacity) at a building and the recycling rate. The R squared coefficient is R=0.75, which indicates a strong correlation. This result has been indicated in previous E&E projects which have found a correlation between recycling capacity and recycling rates E&E 301 (waste audit analysis) and E&E 197 (London)
