# **County of Peterborough**

## **CIF Project # 275**

### **Final Report**

**December 2011**

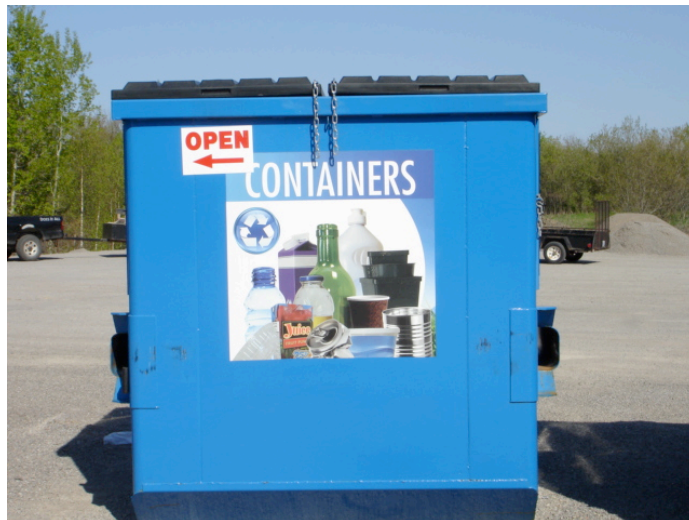
**Photo 1 Front End Bin for Containers**

As part of E & E Project #326, the County replaced the previous bins (30 yard roll-off bins for mixed containers and 8 yard rear load bins for mixed fibres) and replaced them with 8 yard front end bins with dual sliding doors. Photos 1 and 2 show the 'Container' and 'Fibre' front end bins.

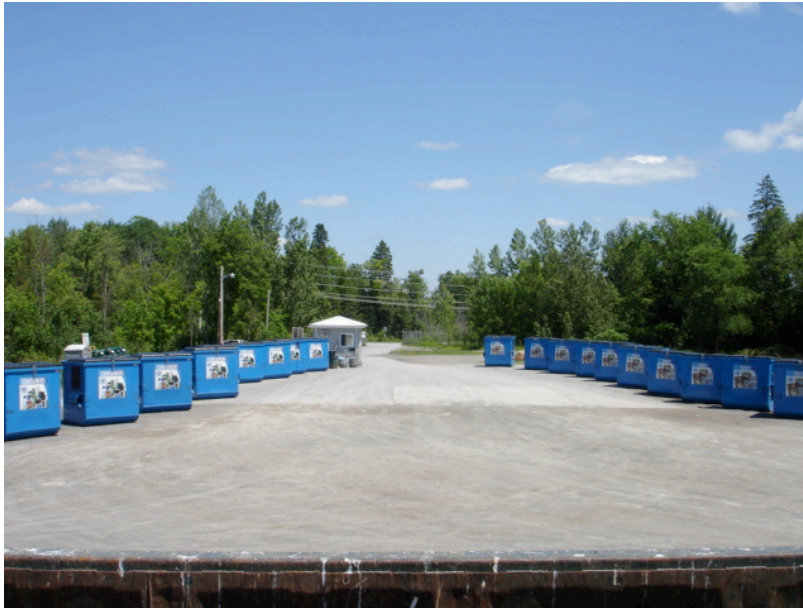
**Photo 3 6<sup>th</sup> Line Belmont Transfer Station**

The photograph below shows the configuration of the front end bins at the 6<sup>th</sup> Line Belmont Transfer Station. The site had 14 fibre bins (on the right in the photo) and 11 container bins (to the left in the photo) with collection of both materials once per week year round.

Photo 3 depicts the 6<sup>th</sup> Line Belmont Transfer Station prior to the compactor.

The 6<sup>th</sup> Line Transfer Station as shown above has ample space for the solar powered fibre compactor and roll off box. The compactor would not impede traffic flow and would remove 14 front end bins from the site.

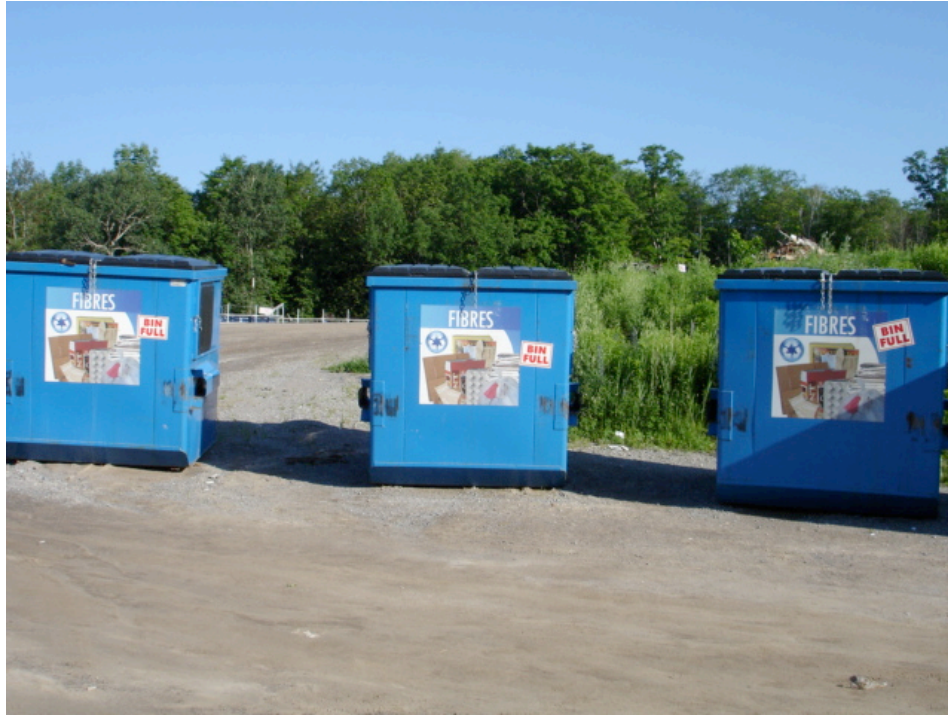
**Photo 4 Fibre Bins at Buckhorn Transfer Station**

The Buckhorn Transfer Station has less space as it recently went from an active Landfill to a Transfer. Buckhorn had 10 fibre bins and 10 container bins with once

Photo 4 shows a sample of the fibre bins located at the Buckhorn Transfer Station.

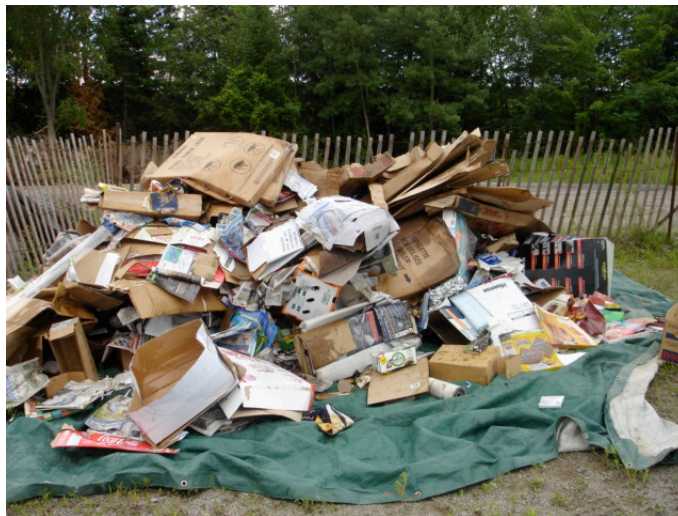
**Photo 5 Fibre Material for Audit at 6<sup>th</sup> Line Belmont June 29, 2010**

The photographs below show the diversity of materials in the front end bins.

As shown in Photos 5 and 6, there were a significant portion of boxes that were not flattened prior to being put in the bins. At 6<sup>th</sup> Line non-flattened cardboard accounted for 12% by weight of the cardboard/boxboard category.

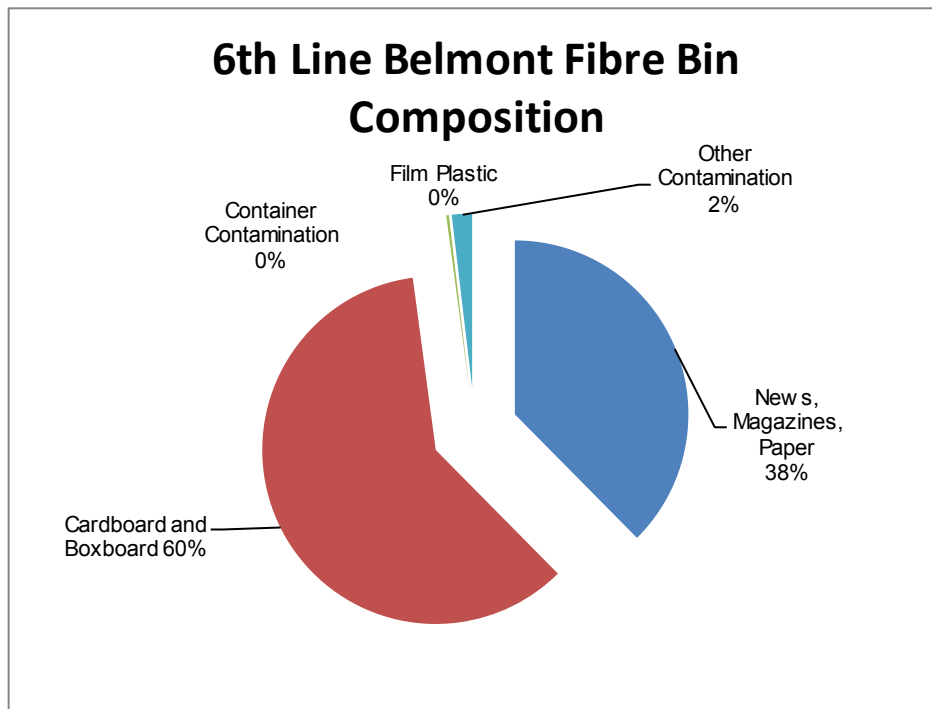
**Table 6.1 Composition of 6<sup>th</sup> Line Belmont Fibre Bin**

The Tables below describe the composition of the fibre bins from the 2 sites.

As shown in Tables 6.1 and 6.2 the amount of contamination at both sites was 2% and 6% (total) respectively. The fibre composition did vary between the sites

most noticeably in the cardboard/boxboard (60% vs 39%) and news/magazines/paper categories (38% vs 50%).

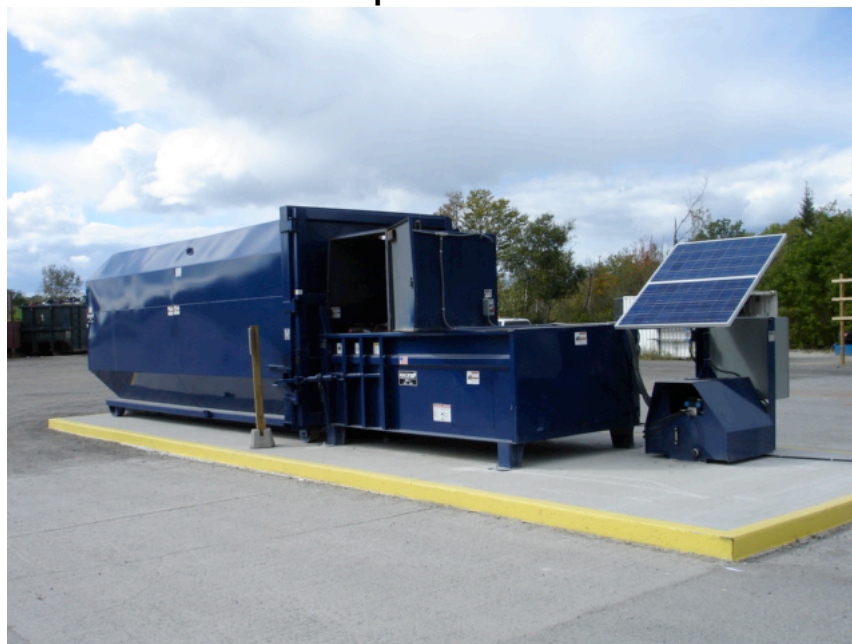
#### **Photo 7 Solar Powered Fibre Compactor at 6<sup>th</sup> Line Belmont**

Photo 7 above shows the raised cement pad with yellow 'caution' paint.

Both concrete pads were installed above ground and therefore created a step up of 6 inches for residents and attendants alike. Yellow paint was purchased and a line around the concrete pad was done for health and safety (as seen in Photo 7).

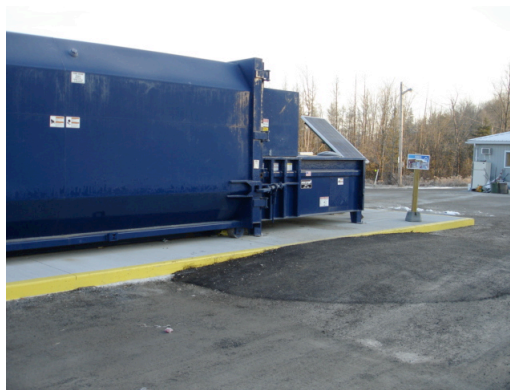
#### **Photo 8 Asphalt ramping installed at 6<sup>th</sup> Line Belmont**

1. Raised concrete pad deemed to create a trip hazard.  
Township staff required a recycled asphalt 'ramp' to be installed on both sides of the concrete pad as shown in Photo 8 below. The installation of the ramp was completed in October 2010 by County Public Works staff at no charge and the asphalt material was \$585.58. The Township requested railings or fencing to surround the compactor and have the solar unit blocked off.

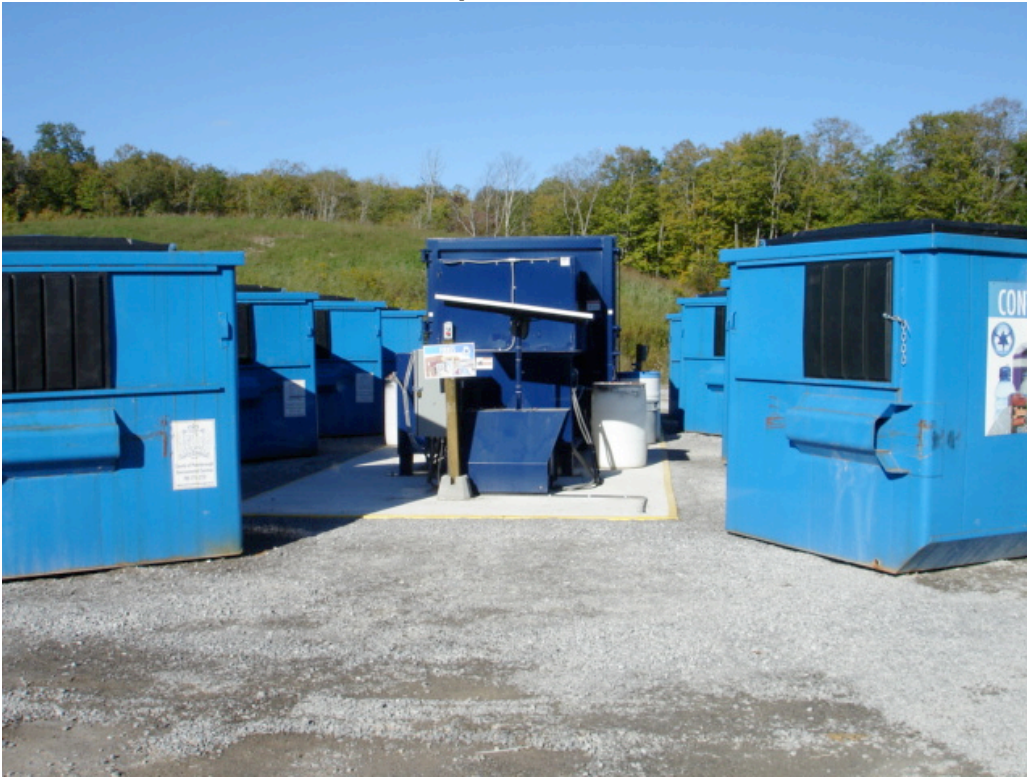
**Photo 9 Solar Powered Fibre Compactor at Buckhorn Transfer Station**

The photograph above of the solar powered fibre compactor at the Buckhorn site shows the difference in layout between the 6<sup>th</sup> Line Belmont and Buckhorn sites.

The Buckhorn Transfer Station opted to surround the fibre compactor with the front end container bins. This would help to expedite residents through the site as they would not have to walk as far to drop off their materials. As well, if the compactor is cycling, residents may drop off their container materials and then their fibre materials.

1. The raised concrete pad at Buckhorn was also an issue.  
As seen in Photo 9 gravel was used to make a gradual grade all around the compactor. This was done by the Township at no cost to the County.
