# Multi-residential Recycling: Implementing Best Practices City of Brantford

Final Project Report
November 24, 2015
City of Brantford
CIF 534.4

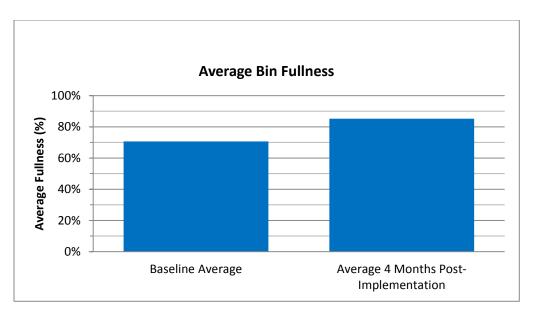
Figure 2: Pre versus post bin fullness at MR locations that received bags from April to December 2014

Figure 2 shows the average fullness of recycling totes observed on completed site visits at 30 selected locations that received bags from April to December 2014 (Appendix D). The baseline average is comprised of data collected from January 13 to May 30, 2014. The average four months post-implementation accounts for each week after delivery of P&E materials and bags were delivered for four months (sixteen weeks). Baseline fullness average was 71%, this increased to 85% post project implementation.

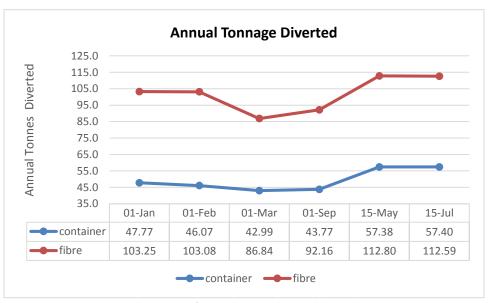
Figure 3: Visual estimate of annual tonnes diverted through MR program

Figure 3 presents a correlation of the fullness data presented in Fgure 2 with density estimates, and the number of carts set out for collection, to arrive at an approximate weight of material set out for collection on an annual basis. Based on the 30 sample locations, and a number of visual audits from January 2014 to July 2015, the average annual tonnes diverted for fibre went from 103.35 to 112.59 and the average annual tonnes diverted for containers went from 47.44 to 57.40.

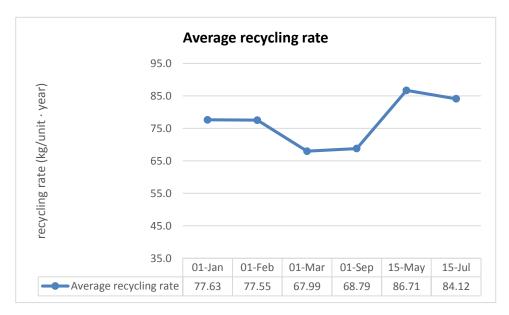
Figure 4: Visual estimate of average recycling rate per year

Figure 4, illustrates this improvement in recycling rates after completion of the project. The average recycling rate, for multi-residential buildings, went from 78 to 84 kg/unit per year.

the recycling rate for MR as 77 kg/unit baseline and 84 kg/unit post project implementation. This represents a 15% increase in the amount of material diverted through the MR program.

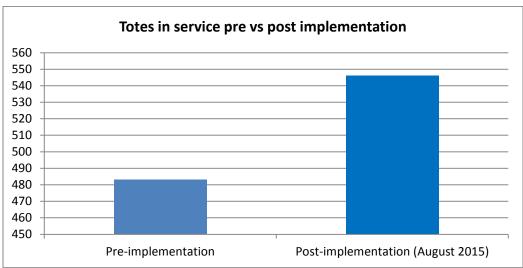
Figure 6: Totes in service before and after program implementation

Moreover, this can be supported by the changing number of totes in service which has increased by 63 over the span of the program, from 483 before program implementation to 546 during the post-implementation phase (Figure 6). This represents a 13% increase in recycling capacity from May 2014 to July 2015.

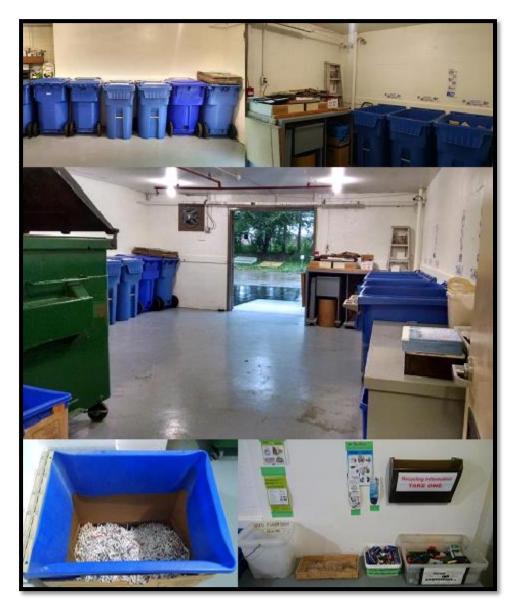
Figure 9: 640 West Street garbage room

Below are images of the waste management room at 640 West Street, which keeps paper and container totes separate, contains a spot to bundle corrugated cardboard, bins for e-waste such as batteries, ink cartridges and light bulbs, and signage to educate tenants on proper waste management.

The room is well lit and kept in very clean condition.

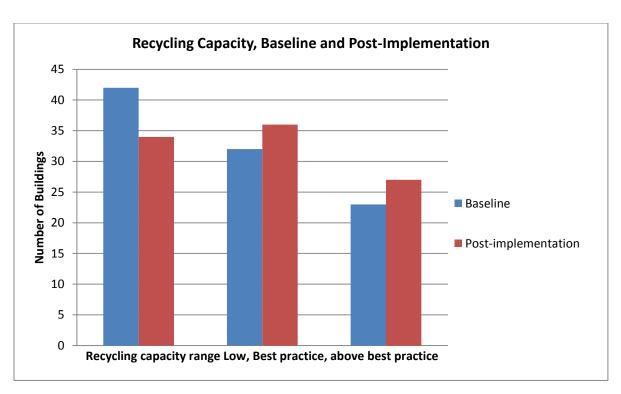
Figure 10: Recycling capacity, baseline and post implementation

The recommended ratio of one 360 litre tote per 7 units in the distribution of recycling totes proved to be sufficient capacity for multi-residential buildings in Brantford. At the beginning of the enhanced multi-residential recycling program, 55 locations were either within or above the recommended range for recycling capacity, compared to 42 that were below. After program implementation however, these numbers improved. Currently, 63 locations are at or above the recommended capacity and only 34 are below. Demand for capacity will hopefully continue to grow as the program evolves and recycling output increases.

Capacity range	Baseline	Post-implementation
Capacity Tange	Number of Buildings	Number of Buildings
Best practice range: 45 to 55 litres/unit	32	34
Low: less than 45 litres/unit	42	36
High: more than 55 litres/unit	23	27
