CIF #
821.3.2

Glass Clean-up System *Niagara Region*

Final Project Report, April 2016

Niagara Region

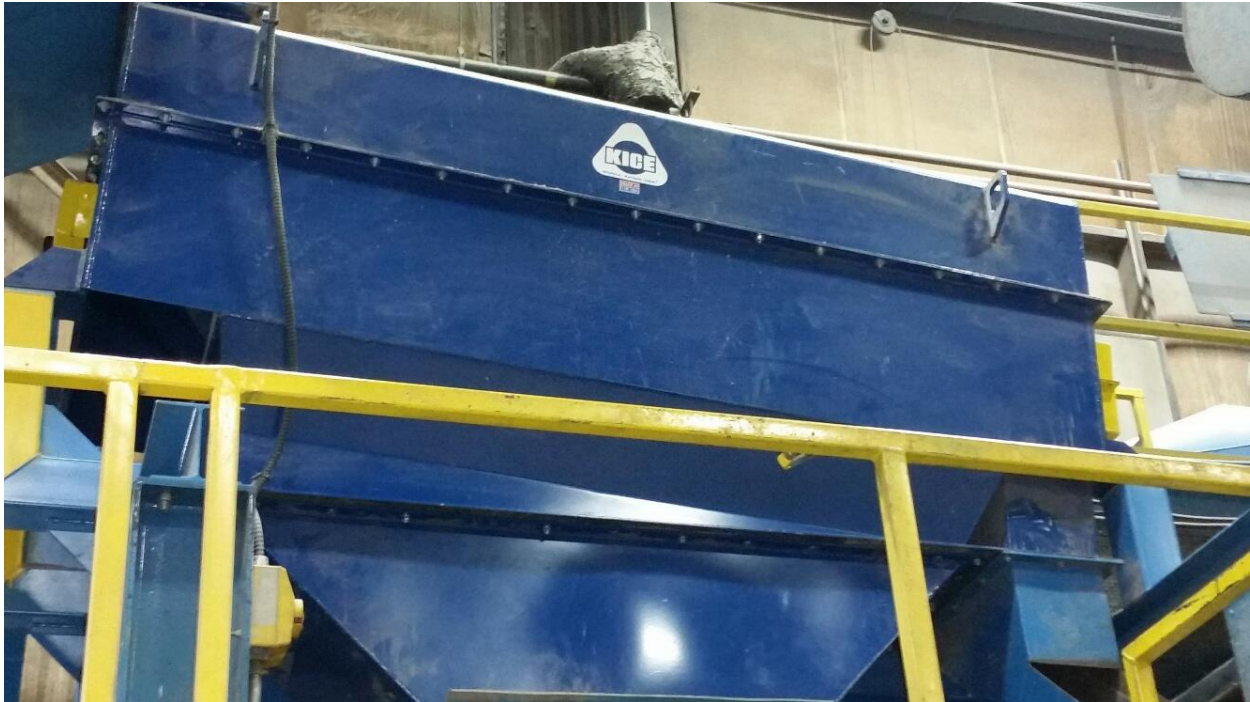
Figure 2: Trommel Screen

The composition of trommel screenings were audited three times over a 12-month period. The total weight of trommel screenings sampled was 61.5 kg. The sample sizes ranged from 17 kg to 24 kg. The sampled trommel screenings consisted of glass > ¼" in diameter (39.1%), 1.1% sieve glass < ¼" in diameter (1.1%), metal (9.2%), and 50.6% other miscellaneous residue (including plastics and other residue). Table 4 presents the composition of the glass feedstock samples. Figure 2 depicts the trommel, and Figure 3 shows the trommel chute and examples of trommel residue.

- **Trommel:** The trommel unit included a cleaning brush that would turn along the outside face of the trommel screen deck. This brush would frequently clog with fine glass and grit, resulting in labour-intensive removal and cleaning. Additionally, the brush was not effective in removing larger debris, such as string, rope and wire, and would cause the 3/4" holes to clog with fine debris. Consequently, the cleaning brush was removed and the trommel screen was opened once per week to manually remove all built-up debris, requiring approximately only 30 minutes of staff time.

- The trommel screen in the Region's application is located after the glass is ground to less than 3/4". In a MRF process, the trommel would have openings of 2" to 3", depending on the type of glass breaker screen used.
- Depending on the quality of a MRF's MBG feedstock, a trommel screen may not be required. However, if the glass is very contaminated it may be useful to have a trommel screen before the aspirator in order to remove long items such as straws or strings, as these can be problematic in the aspirator (i.e., they can jam or get caught up in the aspirator baffles).

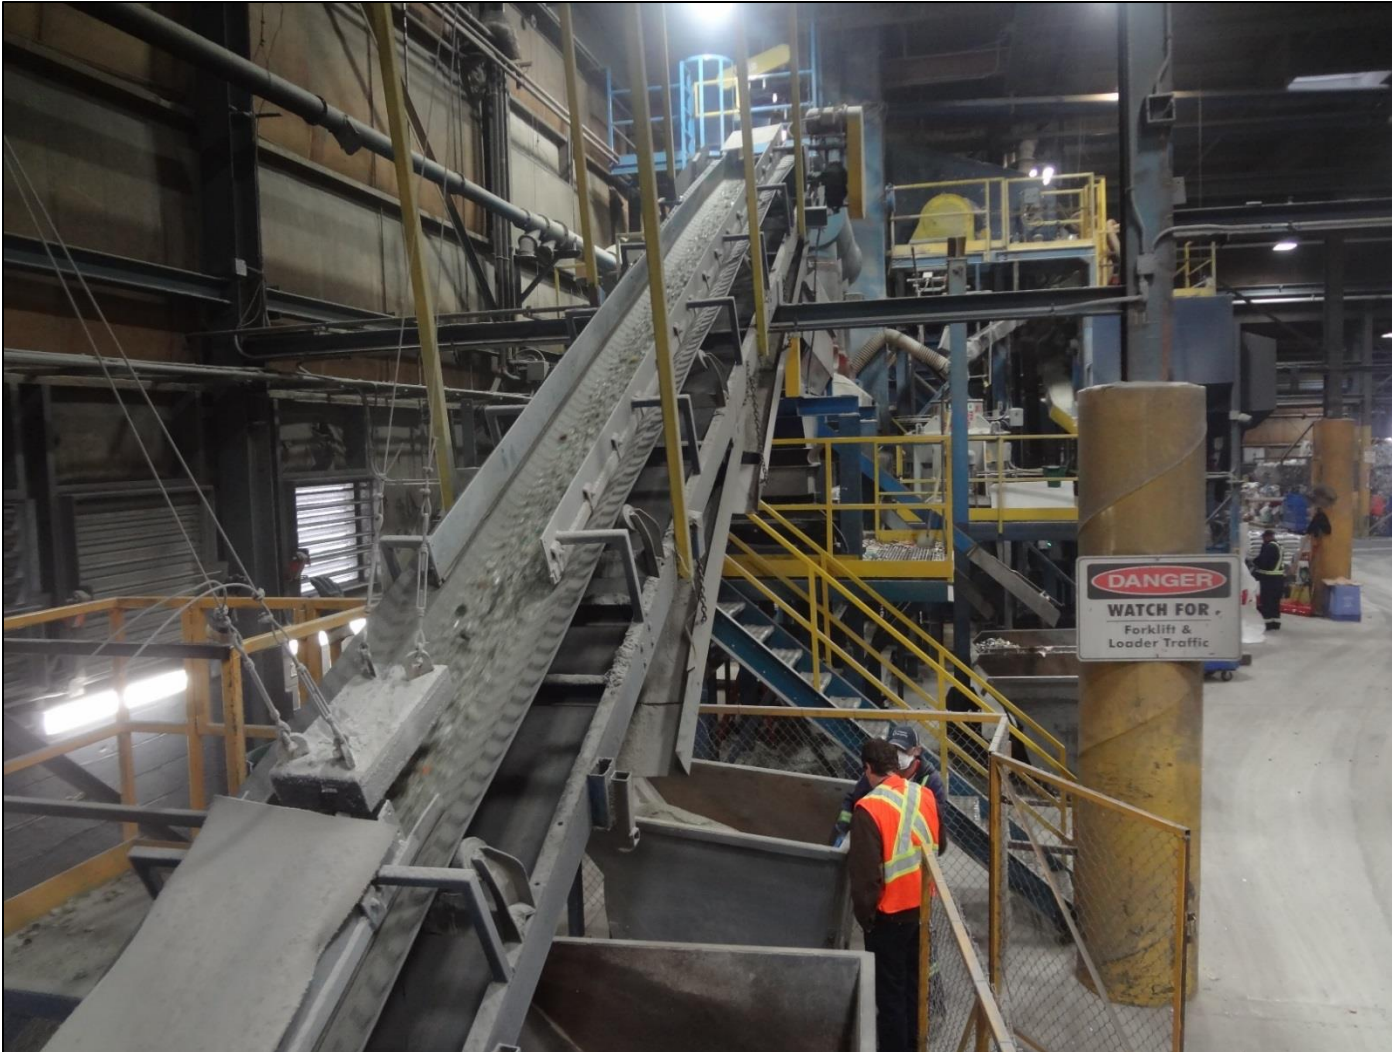
Figure 4: MBG Conveyor Belt

MBG is elevated via conveyor belt into the GCS. Conveyor belt part of the GCS upgrade.

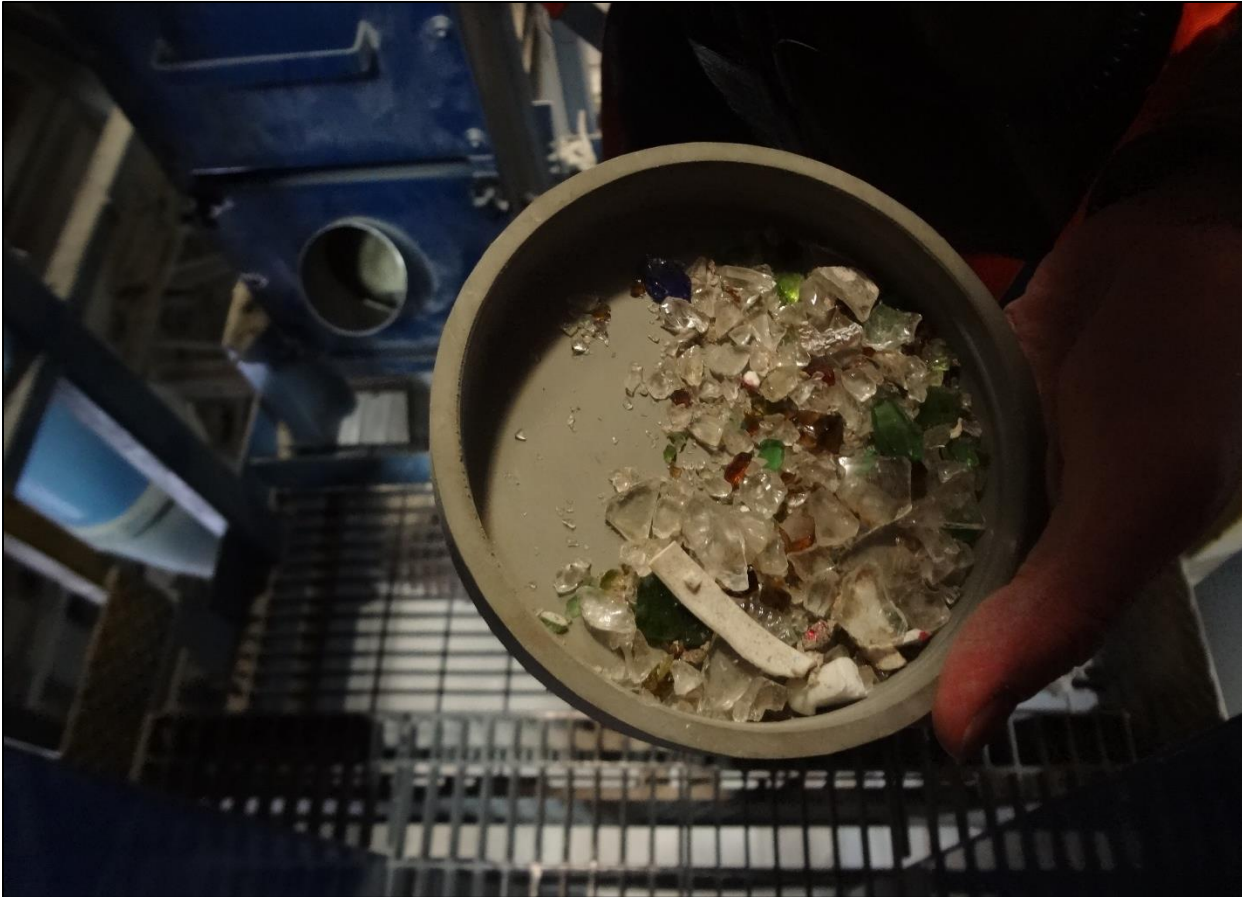
Figure 6: Sample of Glass Pulled from Aspirator Unit

Sample of MBG pulled from aspirator unit.

The GCS is performing well to process the Region's MBG, and the product exiting the GCS is of very good quality (Figure 6 depicts a sample of glass pulled from the aspirator). Lessons learned and advice for other municipalities considering a GCS are:

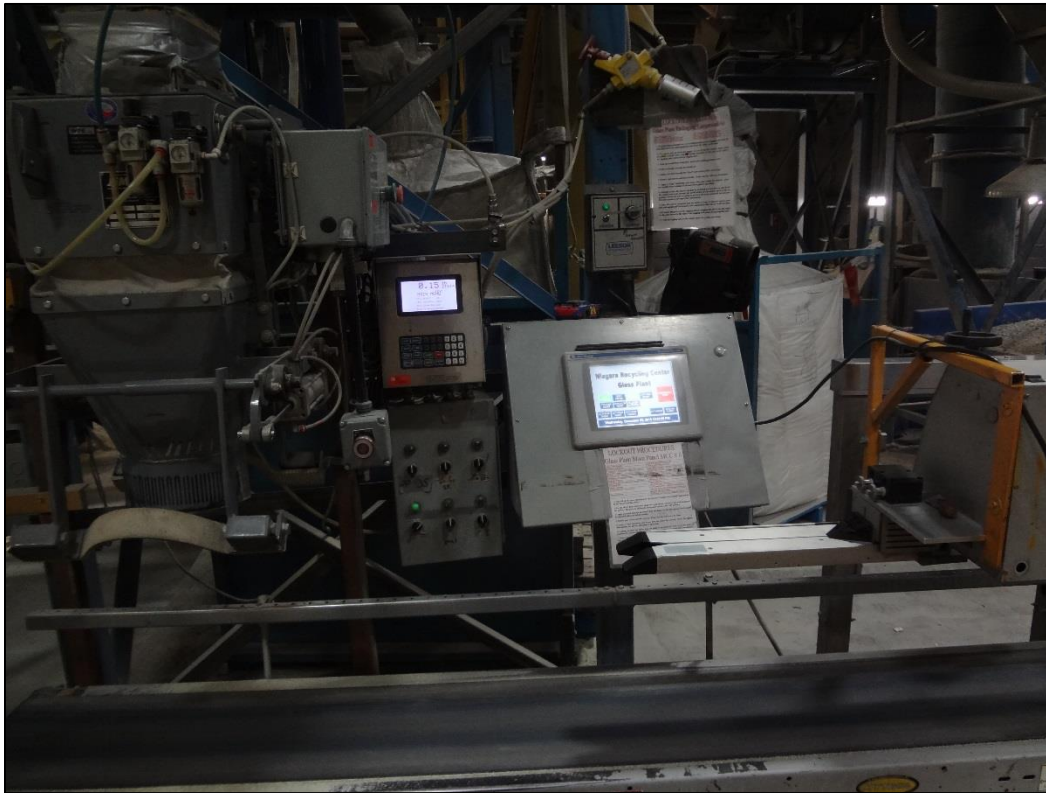
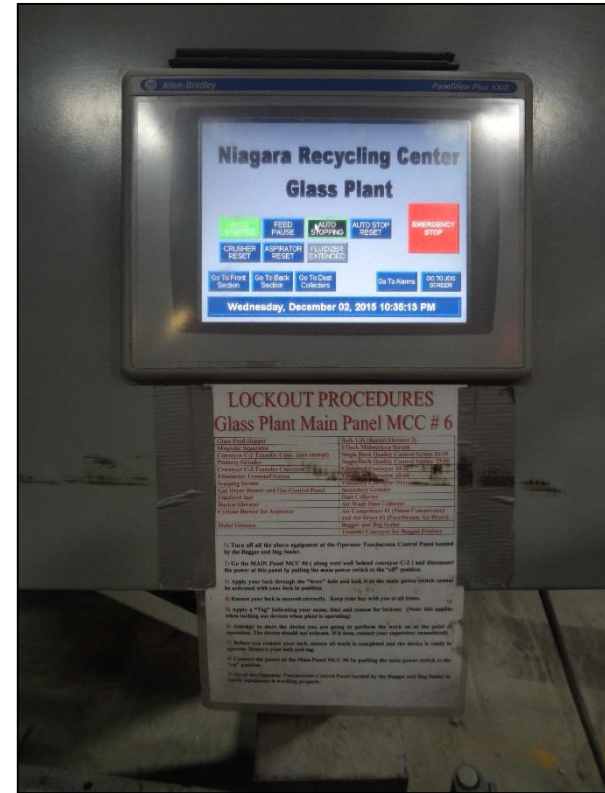
Figure 7: Updated Control Panel

Updated control panel. (Right – wide view; left – close up). Part of the GCS upgrade.
