# Waste Diversion Ontario Continuous Improvement Fund

**TOWNSHIP OF MADAWASKA VALLEY**

**CIF PROJECT #858**

**CONVERSION TO REAR BIN PACKER COLLECTION**

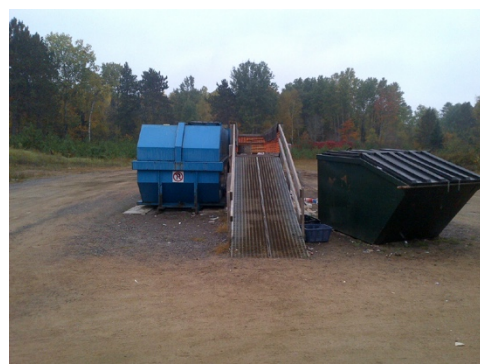
Photo: a typical top load 40 yd<sup>3</sup> recycling bin and access ramp

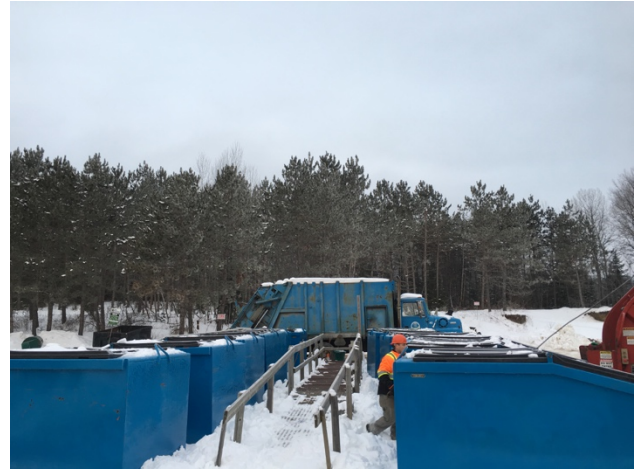
Bark Lake----->

Note that this photo shows the original ramp that was in place to access the previous side panel 40 yd<sup>3</sup> containers of which there were two (one on each side). In this photo, the rear load bins are accessed from the front the containers at ground level.

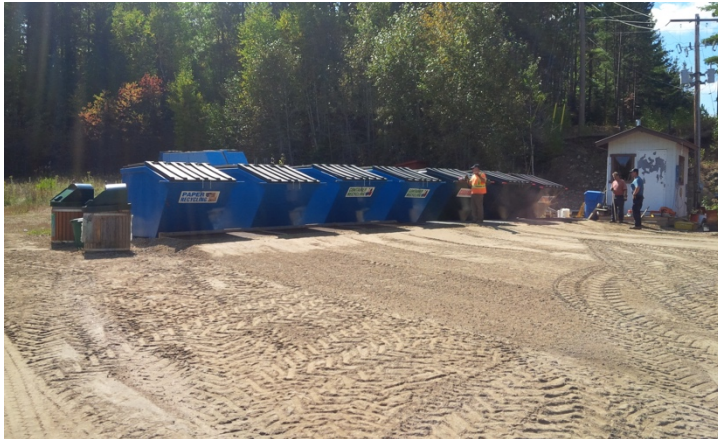
←-----Wilno TS

This Transfer Station was re-landscaped and ramps removed and placement of bins near the attendant's shelter for regular supervision. As is the case at all location, organics is also collected using the Molok system to the left of bins in photo.

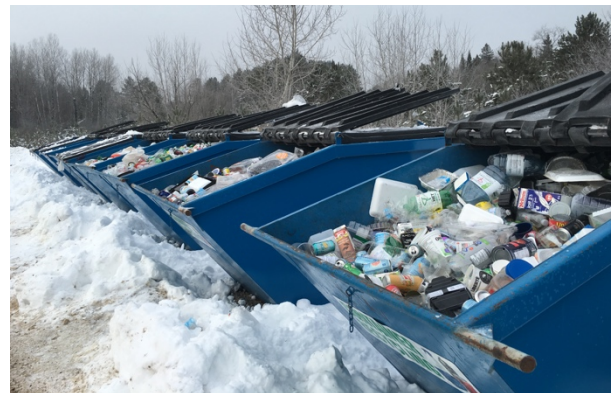
Combermere TS ----->

Similar to the Wilno Site, bins are placed in a single line to allow ease of access for residents with each bin having a magnetic sign in place noting the material to be placed into it for recycling. The bins in this photo have been opened by the driver just prior to collection.

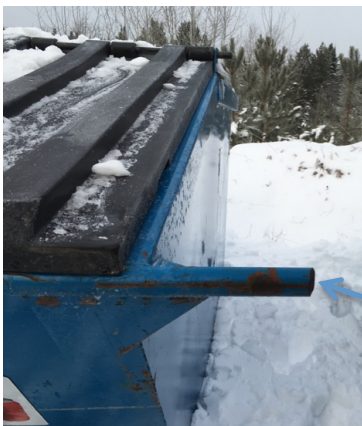
However, not all aspects of the change were without a downside. Staff note that yard maintenance, in the winter specifically, needed a bit of extra time to keep the front of bins clear. With a roll off it was the ramp that had to be cleared, for the rear load bins each bin needs to be maintained. As well, when the truck came to pick up containers, upon bin tipping materials fall out of the hopper via the gap in the side. This overflow requires regular yard clean up by the drivers and attendants. In the case of a roll off, it was not needed unless the wind caught material or a resident dropped something down between ramp and bin.

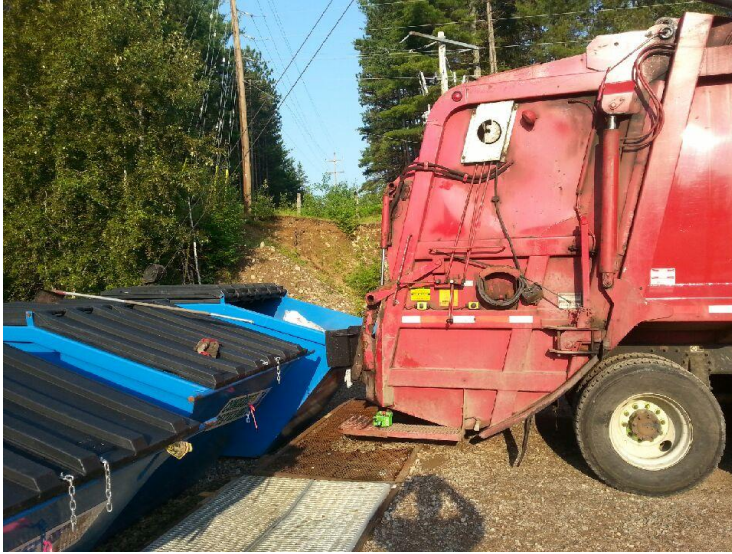
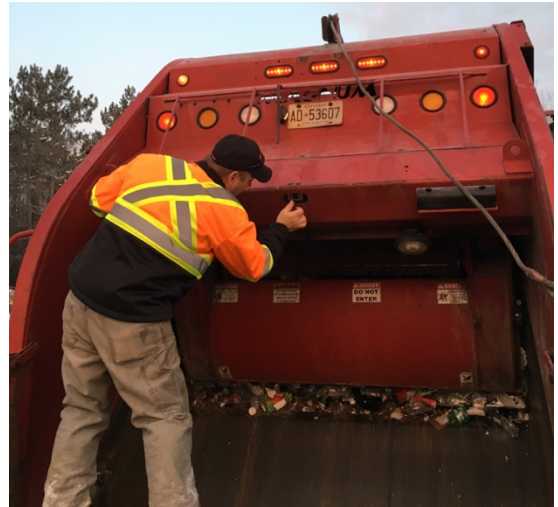
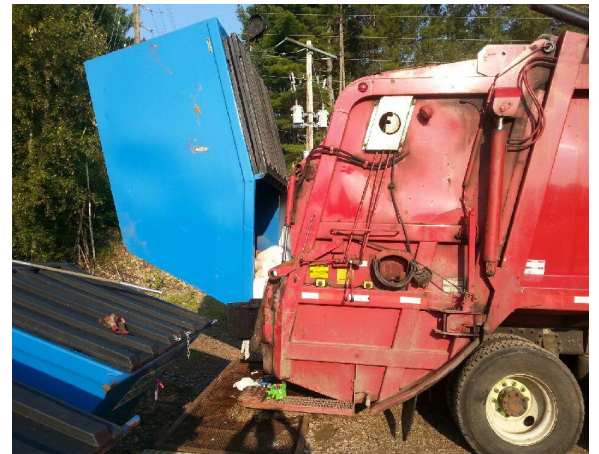
As well, on an operational note, the rear bin rods required minor modification. During fabrication, the tip rods that sit on the truck guide were squared at the ends. Staff modified this to a slight angle so that when the truck backed up to a bin, the bin could shift into place via the angle cut. Previously the square end would not allow the bin self adjust.

Note end of rod has been slightly cut and is no longer square.

During a site pick up, the driver generally cleaned the rear camera prior hooking onto a bin.

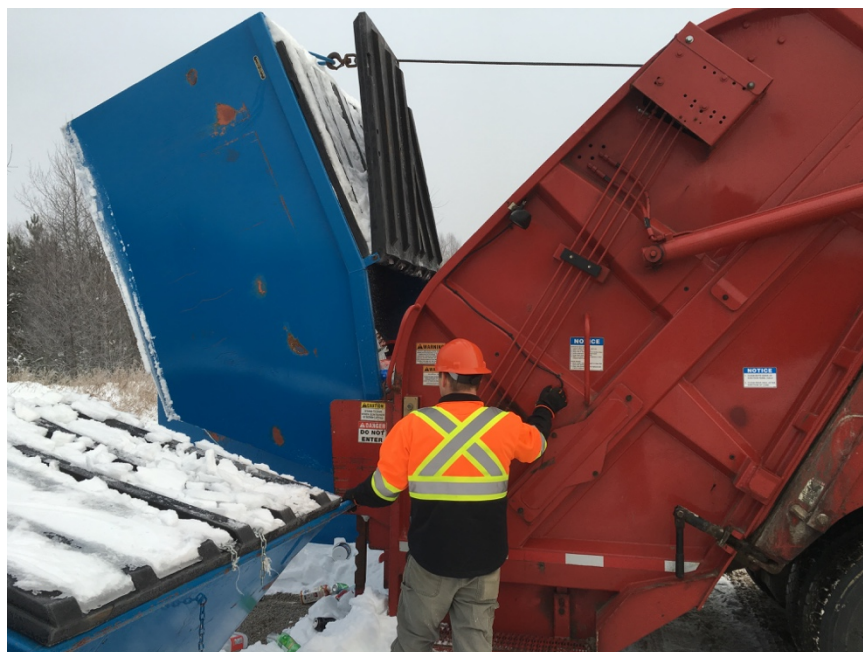
When the truck and bin are in proper position, the lift cable is attached to rear of the bin. The cable control at the rear right of the truck is then utilized by driver to lift and tip the bin into the hopper. Material is then compacted at regular intervals as needed. Note in the two photos here, the driver stepped away to allow for a photo of truck control area. The photo below shows another pick up event and with driver at controls.

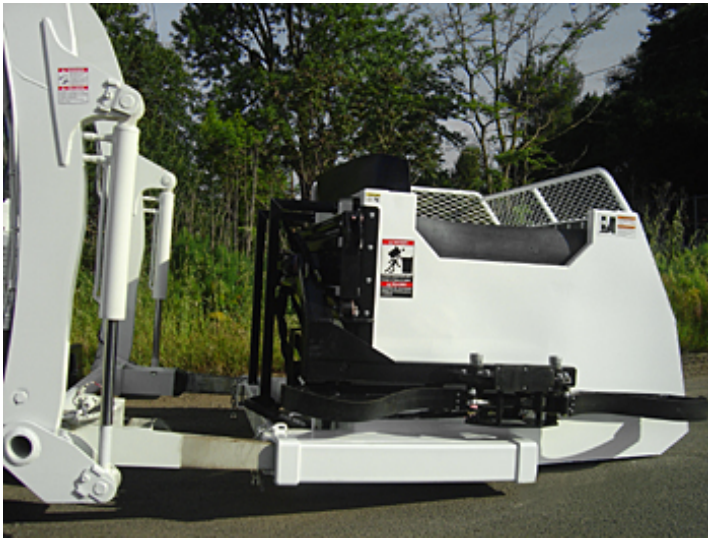
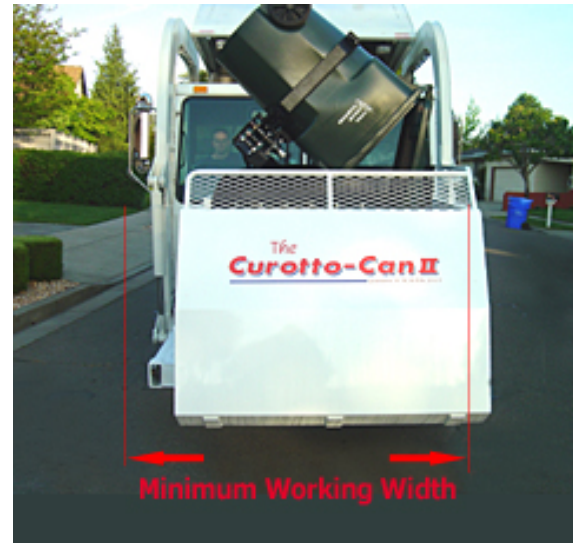
Photos  
from  
<http://www.thecurotto.com/>

As noted in the report, the cycle time of a rear load bin is 5-7 minutes. The cycle time for a Curroto Can is about 30 seconds. Given the number of depot containers collected at each of the 3 depot locations, the time taken could be reduced significantly resulting in further operational savings.

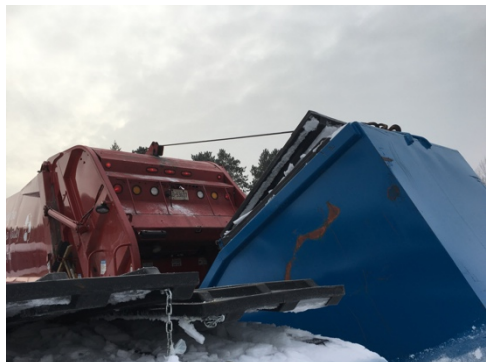
Lifting Cable side/rear view

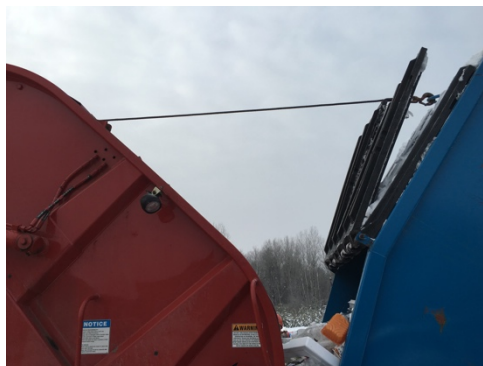
Lifting Cable: side view

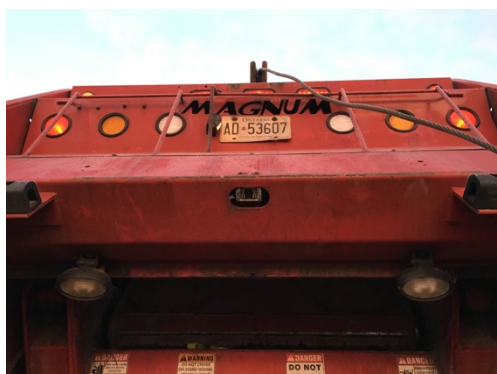
Rear Camera above hopper

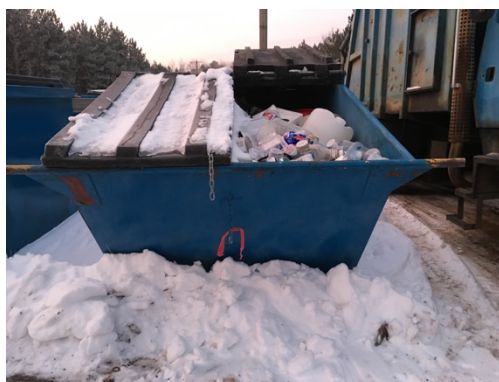
Split Lid rear load bin
