Region of Peel

Material Recovery Facility Efficiency Assessment
and Improvement Recommendations

PREPARED BY: Reclay StewardEdge Inc.

January 2017

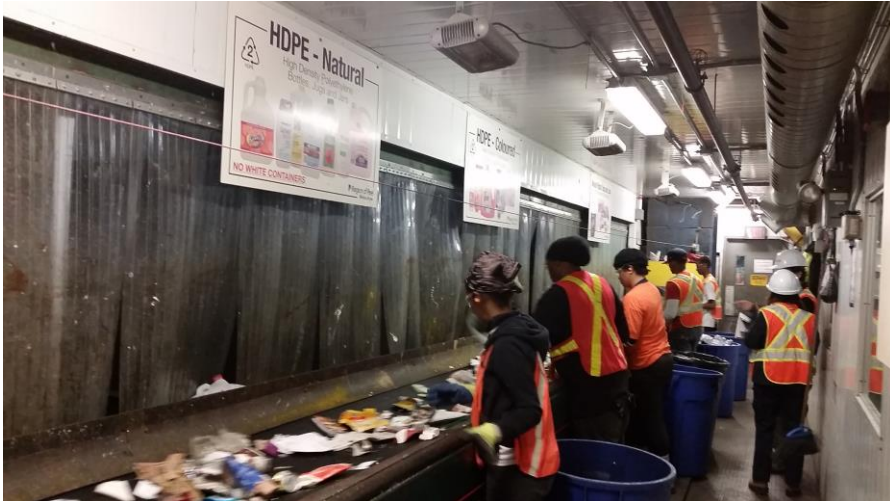
Figure 3 - Container Sort Room

Non-ejected containers from the dual eject sorter are conveyed to the manual container sort room where sorters are positively removing PET, mixed plastics and polycoat cartons missed by the optical sorters. Sorters also separate HDPE into a colour and natural sort. The remaining materials after the manual container sort room go through one last QC sort, whereby one sorter is positively removing plastic film, missed containers and fibre, before letting the remaining materials end up as residue.

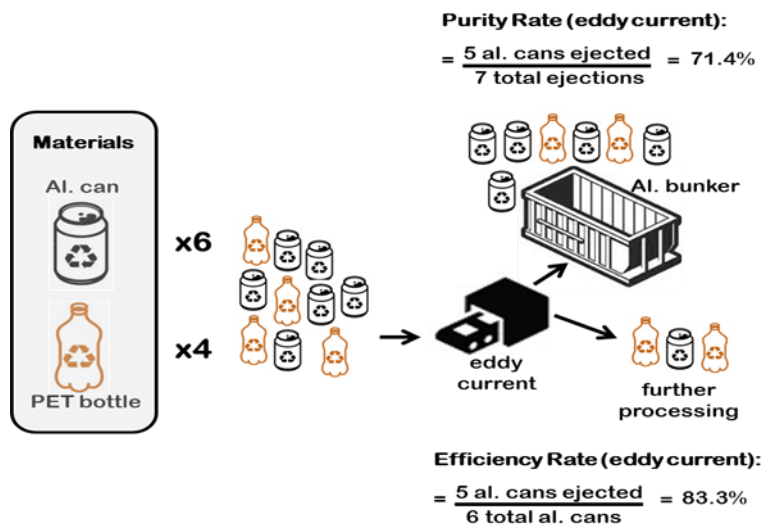
Figure 5 - Illustration of Efficiency & Purity Rate Calculation

The efficiency rate is defined as the ability for each piece of equipment and sorter to correctly identify and sort the material it is intended to sort. For example, the eddy current is intended to target non-ferrous materials (e.g. aluminum). Therefore, the efficiency rate of the eddy current is calculated by dividing the total aluminum found in the aluminum bunker by the sum of all aluminum containers found within the bunker and all subsequent bunkers downstream. It is important to note that the efficiency rate is not calculated by dividing the total target materials captured by the total introduced to the system as there are some material losses prior to reaching the appropriate sorting station. For example, steel lost before even reaching the magnet is not considered in the efficiency calculation, as the magnet never had the opportunity to sort that material.
