Regional Municipality of Waterloo,

Process/Equipment Review, Material Recycling
Centre (MRC)

PREPARED BY: Reclay StewardEdge Inc.

May 2017

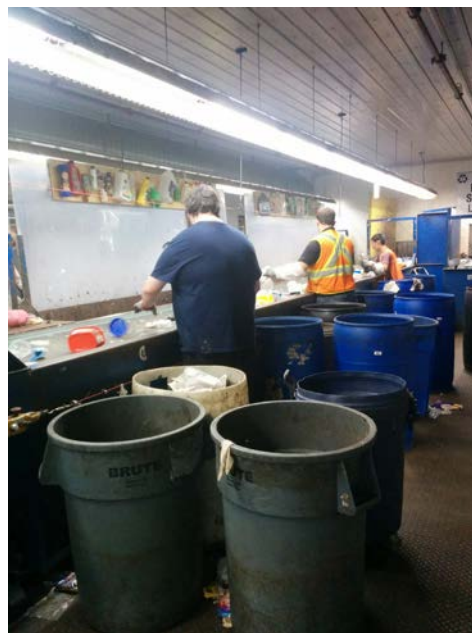
Figure 2: HDPE QC Sort Line

At the PET QC conveyor (C-19), one sorter is responsible for the removal of non-PET containers off the conveyor. Mixed plastic and HDPE containers are directed to the HDPE line. Polycoat cartons, residue, aluminum and fibre/film materials are placed in sort station bins. The remaining PET material on the conveyor falls directly into the storage bunker underneath the platform.

At the HDPE QC conveyor (C-21), three sorters are responsible for the removal of HDPE, PET, polycoat cartons, and residue from the conveyor and placed in dedicated station platform bins. The remaining materials on the conveyor which are now comprised primarily of mixed plastics, fall directly in the storage bunker underneath the platform.

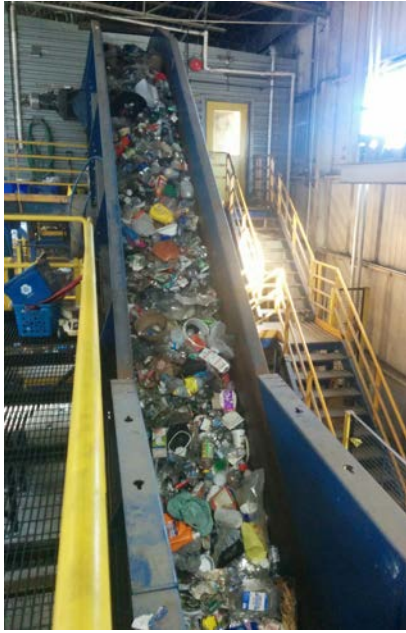
Figure 4: C2 Incline Conveyor

Effective inbound material infeed provides a consistent flow of materials and eliminates mounding and uneven distribution of materials (i.e. black belt) on the sorting line. At the MRC, inbound materials are fed onto C1 using a front-end loader. The materials are then automatically transferred to the C2 conveyor, which as a result of space limitations, is at a relatively steep incline of 35 degrees. The absence of material adjustment at C1 and the steep incline at C2 has created the following conditions:

- Some material roll back from C2 to C1
- Presence of black belt at the pre-sort
- Piles of varying depth at the pre-sort

A primary recommendation is the installation of drum feeder at the front-end of C1 to provide an effective mechanism for material presentation and declump compacted recyclables collected as part of the impending collection changes in the Region. Without a declumping mechanism, material capture rates and sorting efficiencies will be greatly reduced.
