CIF Final Report #957

Durham Region MRF Container Line Productivity and Efficiency Upgrade

September 2019

Prepared for:
Resource Productivity and Recovery Authority
Continuous Improvement Fund

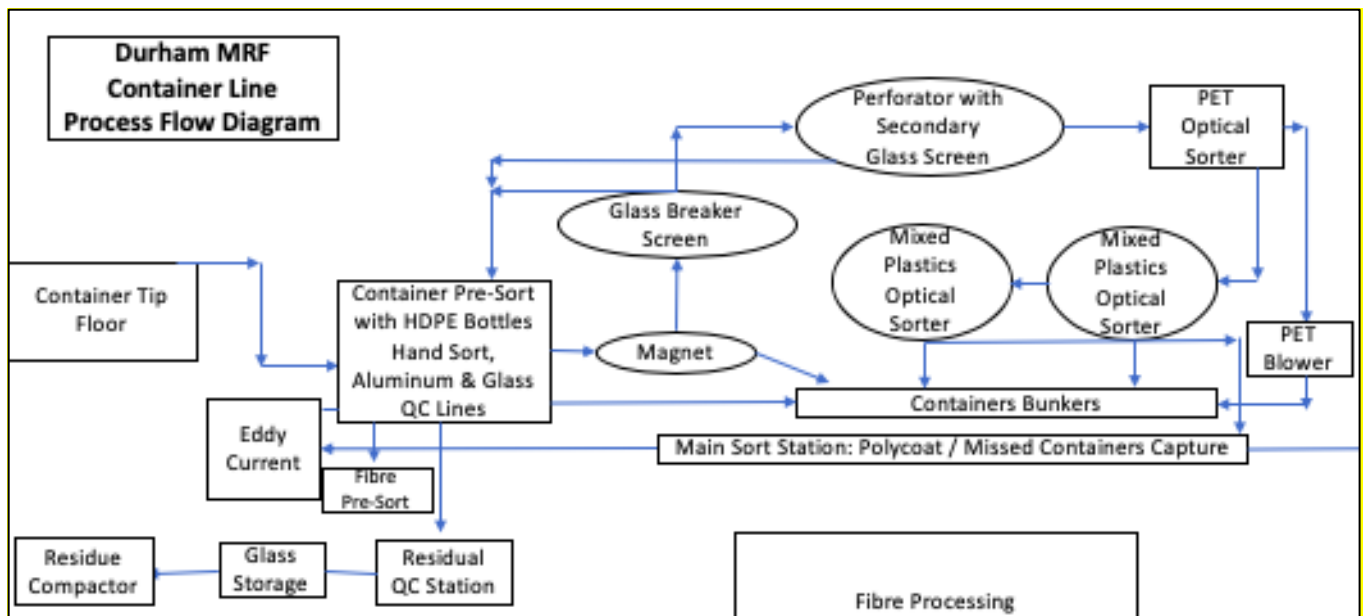
Figure 2: Durham MRF Container Line Diagram

The upgrades to conveyers and the addition of new equipment increased the MRF’s processing rate from 6 tonnes per hour to 9.5 tonnes per hour – a 58% increase in throughput. A schematic drawing of the new container line system is provided in Figure 2 below. For a complete MRF processing diagram see Appendix C.

3.2.1 Pre-Sort Line

Most contamination is positively hand sorted and removed at the beginning of the sorting process to ensure it does not interfere with the sorting equipment and sort stations downstream. Incoming loads of containers are emptied on the MRF’s tip floor and large unacceptable materials, over-sized plastics, and film plastics are removed manually. Containers arriving in tied off clear plastic bags are also manually opened and emptied onto the tip floor by collection drivers or MRF staff.

Materials are then loaded into the inclining conveyor and moved to the pre-sort room. Recyclable fibres, large unacceptable items, over-sized plastics, and bagged materials are hand-sorted from the main line and dropped to a residue line and a fibre line. At the end of the pre-sort line, HDPE bottles are manually removed and dropped to a storage bunker below.

3.2.2 Sort Section 1 – Steel and Glass and Plastic Separation

Conveyors move the materials to a magnet and glass breaker (replacement for the original glass screen and heavy-light air cyclone). Steel is conveyed to a bunker. Glass is conveyed back to the pre-sort room for final quality control sorting before going to the indoor glass bunker.

3.2.3 Sort Section 2 – Plastics

The main line materials then move to the new high-volume plastics perforator which punctures bottles release any liquids and to allow for them to be better compacted. Another screen underneath the perforator captures any small and heavy items that may drop through the process. This allows for a secondary glass removal function.

Plastics are then moved to the new PET optical sort room which blows PET to a separate line and conveys the remaining materials forward on the main line. Prior to leaving the room, the PET line has a manual Quality Control station that removes any light material (film or paper) contaminants that may be blown off with the PET materials. Finished PET is air blown through a piping network to a newly expanded PET storage bunker.

The main line then proceeds through two Pellenc optical sorters which are currently set to single eject mixed plastics into bunkers and the remaining materials move to the main sort room.

In the main sort room, the focus is hand sorting aseptic/cartons, other non-aluminum recoverable containers, and any mixed plastics that may have been missed by the optical sorters.

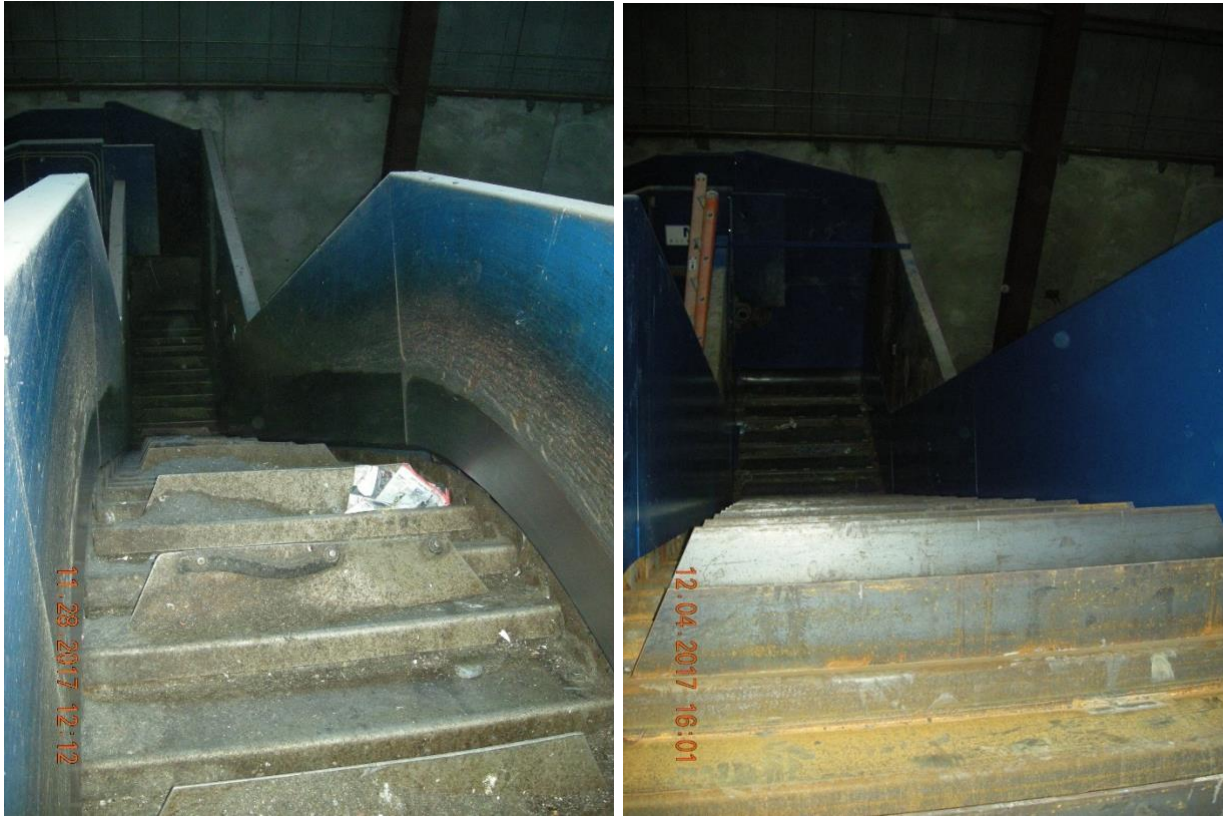
Figure 3: In-Feed Conveyor Pre and Post Upgrade

- Materials rolled back, which increased the amount of time needed to convey all the materials onto the container line (i.e., lengthened operating hours required). This was more problematic in the winter months when the containers were frozen and heavier (ice and snow).
- Poor material distribution (i.e., black belt) was experienced at the pre-sort, meaning there was moments of time when no materials were on the belts to be sorted, which is an inefficient use of equipment, utilities and labour.
- Surges or piles of material of varying depth at the pre-sort, meaning manual sorters and equipment were unable to see buried materials, which resulted in missed capture and again inefficient use of the equipment utilities and labour.

A wider in-feed was installed which improved throughput and lessened material depth on belts for greater capture by hand sorters and equipment. The upgraded in-feed conveyor increased from 36 inches to 60 inches in width and increased the motor size from 5 horsepower to 7.5 horsepower.

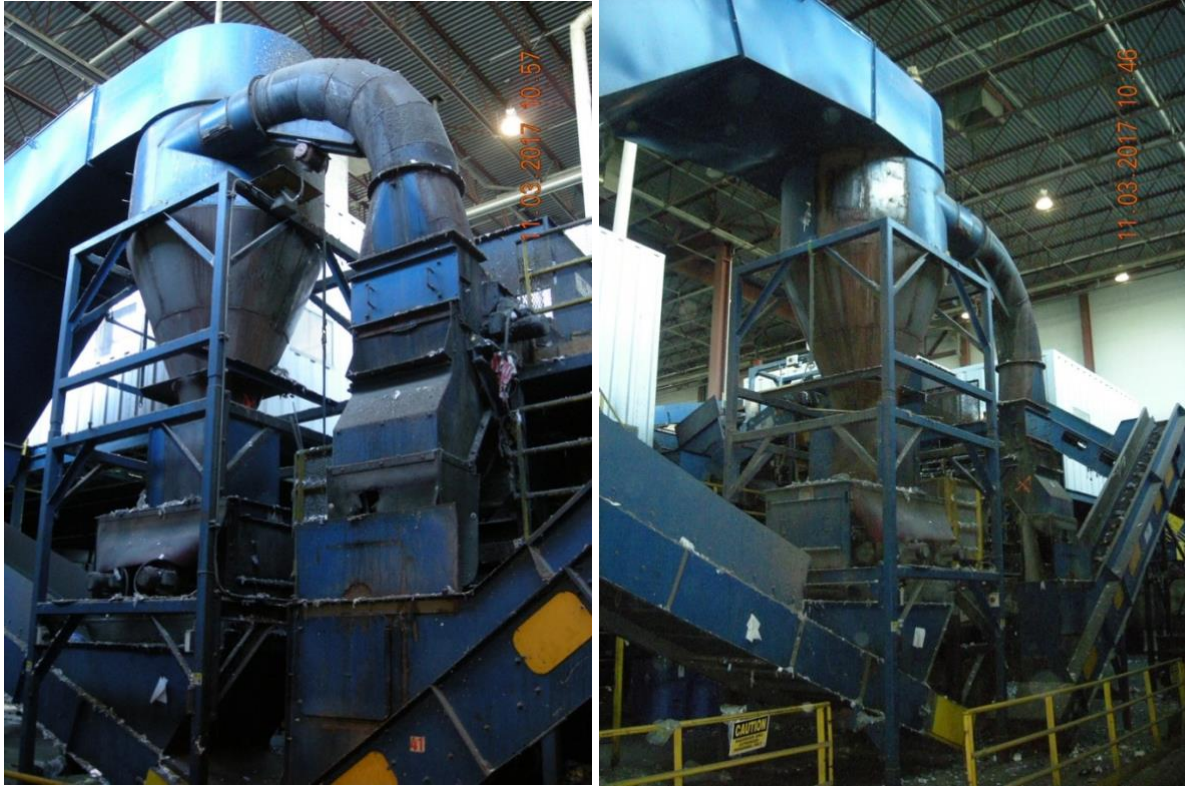
Figure 4: Air Separator Cyclone and Glass Screen Before Removal

Glass missed by the air separator cyclone was also increasing wear and tear on the downstream conveyor belts and equipment which increased downtime and equipment maintenance costs.

In light of the above, the Region elected to remove the air separator and the old glass screen and replace it with a new, more robust glass breaker unit.

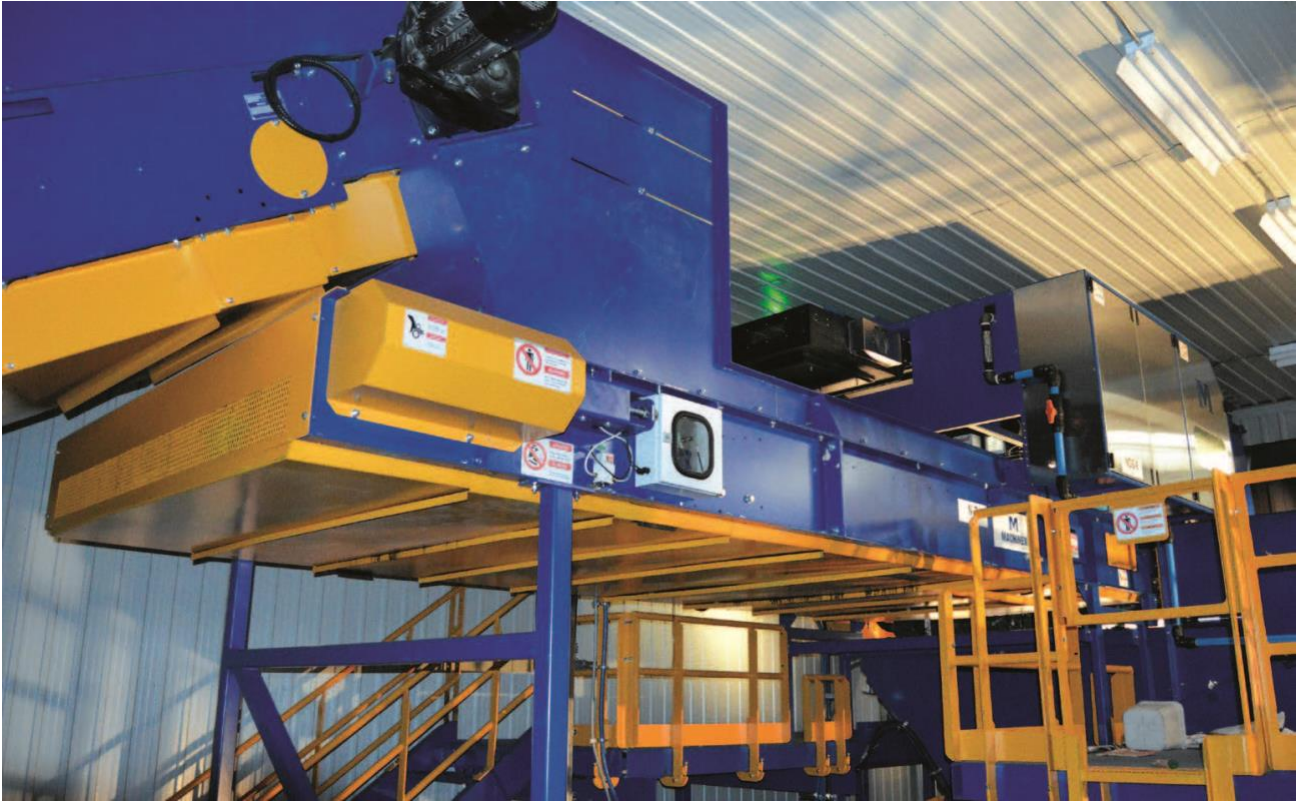
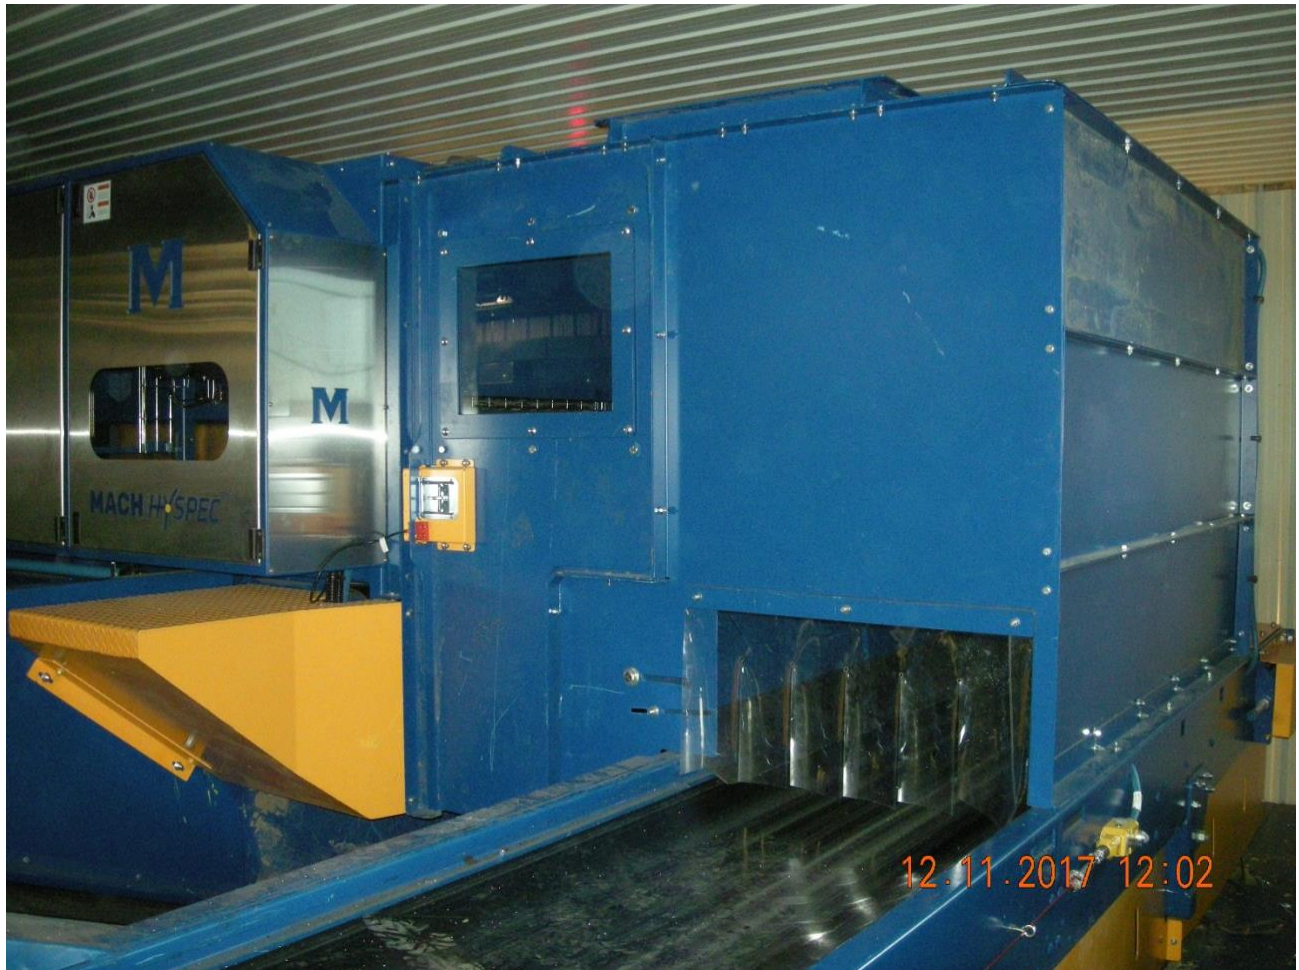
Figure 7: New PET Optical Sorter

A new two-metre wide single-eject Machinex Mach Hyspec optical sorter was installed to target PET. The new optics speed belt minimized the depth burden on the main infeed conveyor belt and the wider belt accommodated the increased volume of materials throughput. Further, a new PET quality control manual sort station was installed after the optical unit to remove any contaminants from the optically ejected PET. Due to space limitations, a unique transport system involving an air blower and piping directs finished PET to an expanded bunker area.

The Region assessed throughput, tracked marketed material (pre-post in relation to inbound tonnage) and noted residual to measure the impact of the PET optical sorter. For detailed results see Section 0.

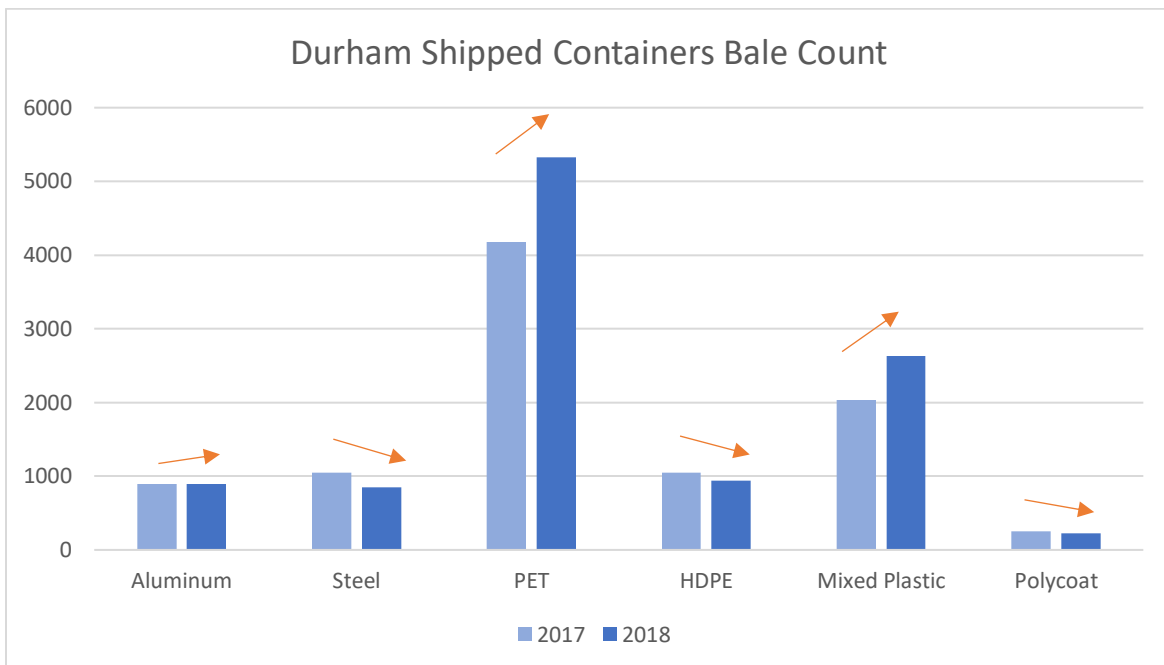
Figure 10: Container Bale Counts 2017-2018

According to Figure 10, the bales of material shipped have increased for PET and Mixed Plastic when comparing 2017 and 2018 despite the decrease in inbound tonnage. This suggests that more of these materials have been captured in the newly upgraded system. As an additional benefit, aluminum capture has also increased. Since the eddy current is last on container line, it is suspected that less depth burden has improved its capture efficiency.
