**Curbside Recycling Contamination Bin
Inspections
City of Toronto Report 1012**

City of Toronto, Curbside Recycling Bin Contamination
Inspections
CIF Project Number 1012

Final Report
Date: *March 29, 2019*

Prepared by: Kevin Vibert
Senior Projects Coordinator
City of Toronto
Solid Waste Management Services

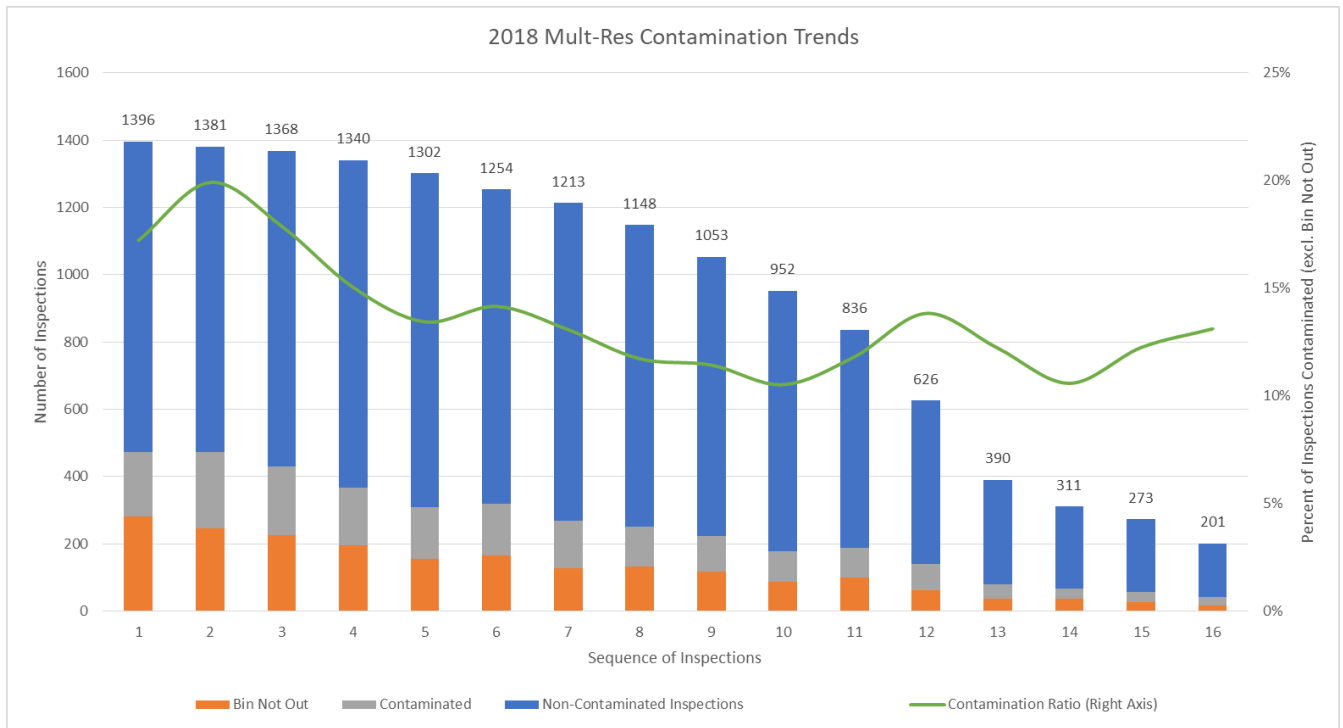
Figure 3 – Recycling Contamination Present in Follow up Inspections

In total there were 15,122 multi-residential curbside collected recycling bins initially inspected in 2018, of which 1,862 bins were tagged and not collected due to excessive amounts of contamination, representing 12.3% of the total bins inspected. Tracking the data for follow up bin inspections based on the bin serial number similar to the single family locations was not feasible due the fact that there are often several buildings in a complex that use the same bins and not all bins are placed out each time for collection. Therefore, due to these challenges the tracking approach taken for the follow up visits and data analysis on recycling contamination was based on the property location/customer to determine if behaviour was corrected after the initially recycling contamination inspection notice was left. Since the number of multi-residential locations are on a much smaller scale compared to the number of single family customers, we were able to conduct follow up inspections more frequently at locations observed with contaminated recycling bins. Some multi-residential locations were visited up to 15 times if contamination remained present from the previous inspection. The findings indicate that some properties did change their behaviour once initially inspected, while others took more persistence to correct their recycling habits and some locations did not significantly improve their poor recycling practices. Reasons for those that did not improve improper recycling behaviour are probably similar to the issues that surround recycling contamination in larger multi-residential buildings such as property management inactions, bin storage locations, etc. Figure 3 - Recycling Contamination Present in Follow up Inspections, below illustrates the follow up behaviour recycling improvement trend based on the ratio of inspection visits.

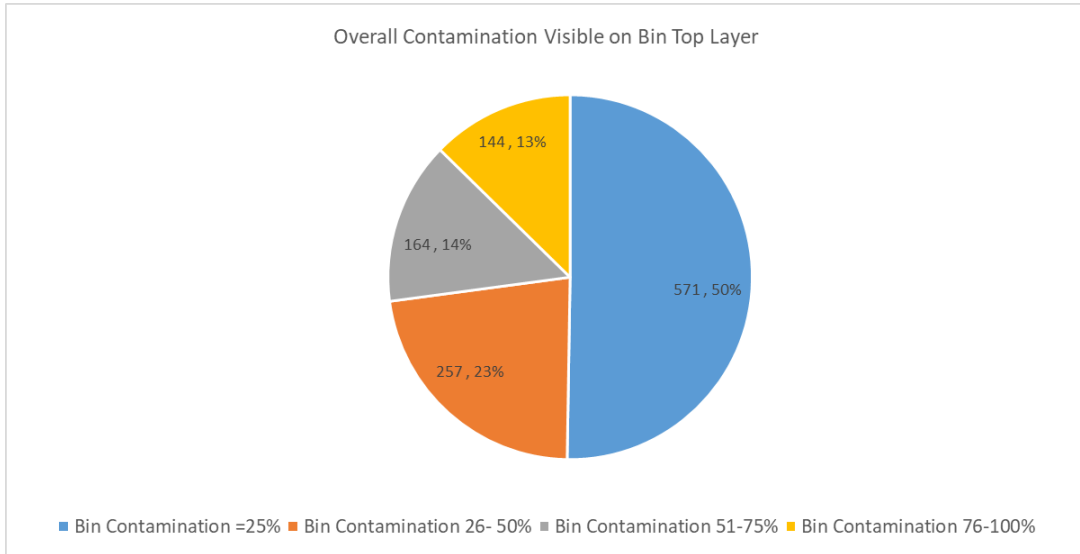
Figure 4 - Overall Contamination Visible on Bin Top Layer

In total 10,050 recycling bins were inspected for excessive contamination using the rear packer dumping method in all four collection districts. The first step was to conduct the visual open top inspection on the each recycling bin to determine if contamination was present, in total 1,136 contaminated bins were identified, representing 11.3%. The bins were then dumped in the truck to determine if there was contaminated material that was not visible from the top layer inspections. In total 361 bins were identified as having excess contamination that was not identifiable on the top of the bin, representing 3.6% of the total bins inspected. These finding suggest that the visual lid opening method works to identify contamination and that there is not an abundance of contaminated material that is hidden in the bins. The packer inspections findings indicate a higher overall percentage of contaminated bins at 14.9% compared to the single family curbside inspections at 5.4%. However, most of the routes selected for the packer inspections were in areas where high levels of contamination was previously identified and this accounts for some of the discrepancy. The truck used for each inspection were taken to a transfer station at the end of the day and the weights were recorded. In total 113.78 tonnes of material was collected during the packer inspections equaling a recycling bin average set out weight of 11.32 kg.

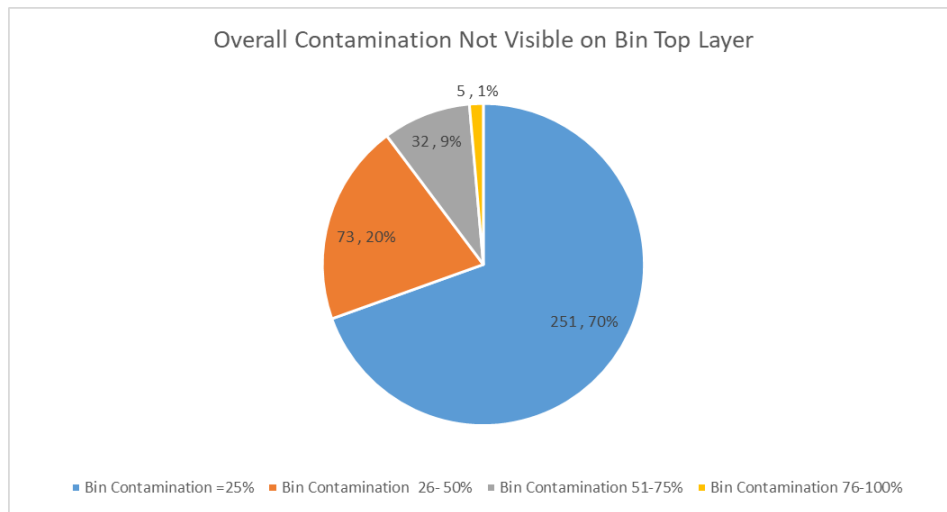
Figure 5 – Overall Contamination Not Visible on Bin Top Layer

Additionally, the bins recycling material was dumped and the contents was spread out in the truck hopper to allow for a more accurate visual assessment on the percentage of contamination in the recycling bins. The findings suggest that visually inspecting the top layer of a bin is a viable method for estimating the bins true amount of contamination. For details on the contamination composition see below Figure 4 – Overall Contamination Visible on Bin Top Layer and Figure 5 - Overall Contamination Not Visible on Bin Top Layer.

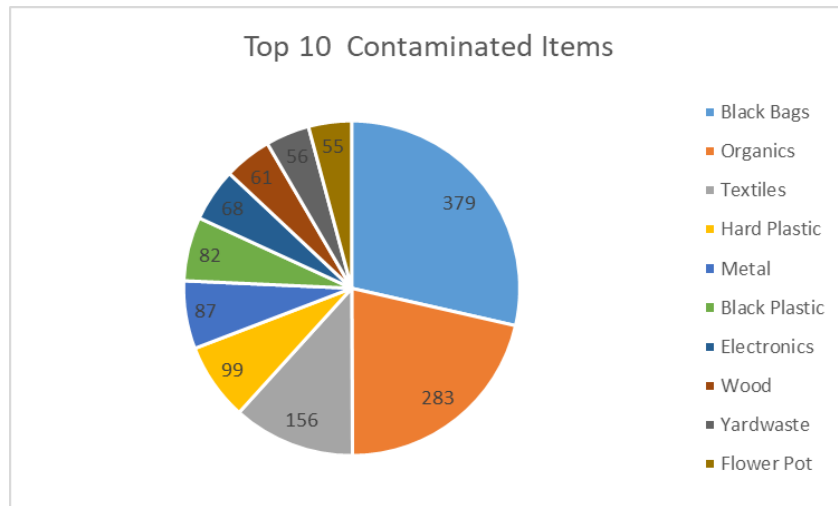
Figure 6 – Top 10 Contaminate Items

The packer truck inspections also recorder the type of contaminants found in each contaminated bin to determine if there were material contamination trends. In total there were 1,637 contaminated items identified of which the top 10 items represented 81% of the total, see below Figure 6 – Top 10 Contaminate Items.
