Energy Conservation Project Commissioning Report

City of Guelph Material Recovery Facility

Rose Technology Inc.
5525 Eglinton Avenue West, Suite 100
Toronto, Ontario, M9C 5K5

February 9th, 2012

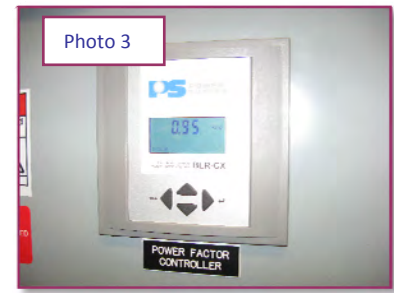
On May 4, 2011 commissioning inspection was conducted during MRF process operations and readings were taken from 250 kVAr Power-Survey onboard controller and metering display (Photo 3). Meter display readings were recorded on commissioning report and varied from 0.94 PF to 0.97 PF with all three steps of capacitor bank operational and actively working to correct power factor. Voltage, Amperage and Power readings were also taken from the meter display (see Table 2.1.2 and Table 2.1.3 below).

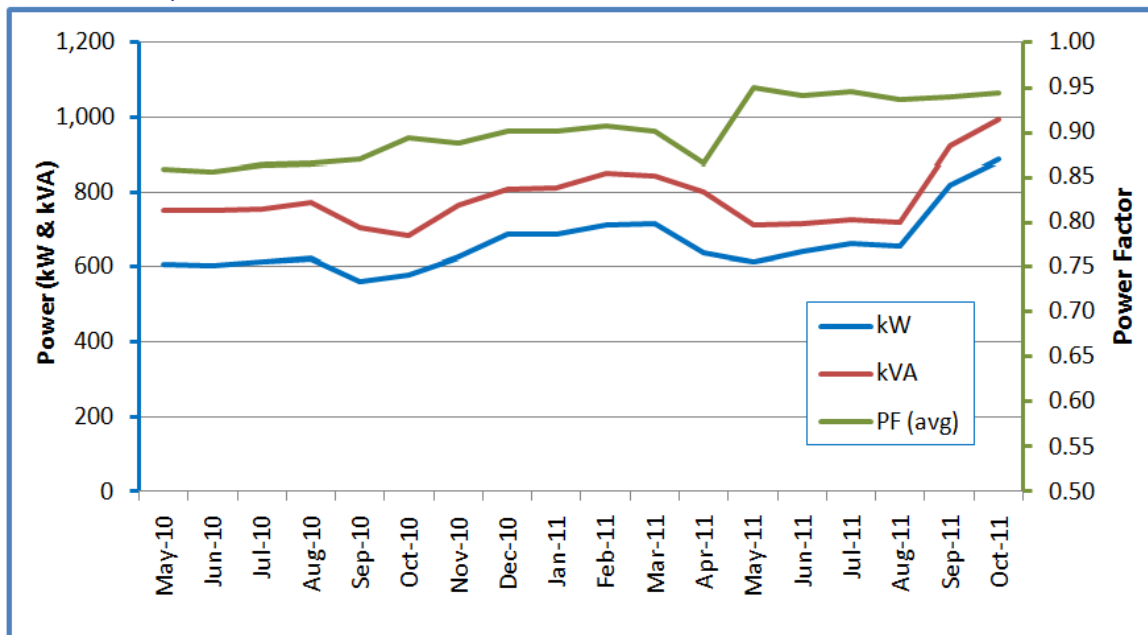
Graph 1: Details the Electricity Peak Power and Average Power Factor Correction for the 18-months from May 2010 to October 2011.

The higher the nominal penalty estimated for May 2011 was due to power factor correction system initial self-adjustment and stabilization after start-up; it is assumed that power factor penalties for the proceeding months after October 2011 will be much less then first six (6) months. However new additions to the site's electrical load profile may vary results in the future.

Note: Power Factor Correction Unit was activated on May 1, 2011 and for the following six (6) months the average monthly power factor PF (average) for the MRF site was above the 0.90 (90%) which is PUC power factor penalty threshold. Power factor was also stable throughout the MRF additions of two new 10 horse-power bailers and the addition of the new Compost Plant building in September 2011 to the site electrical load. The influence of new 107,600 SF Compost Plant additions can be seen in the graph with a sudden rise in electrical power (kW & KVA) for the period of September 2011 to October 2011 when load was brought on-line.

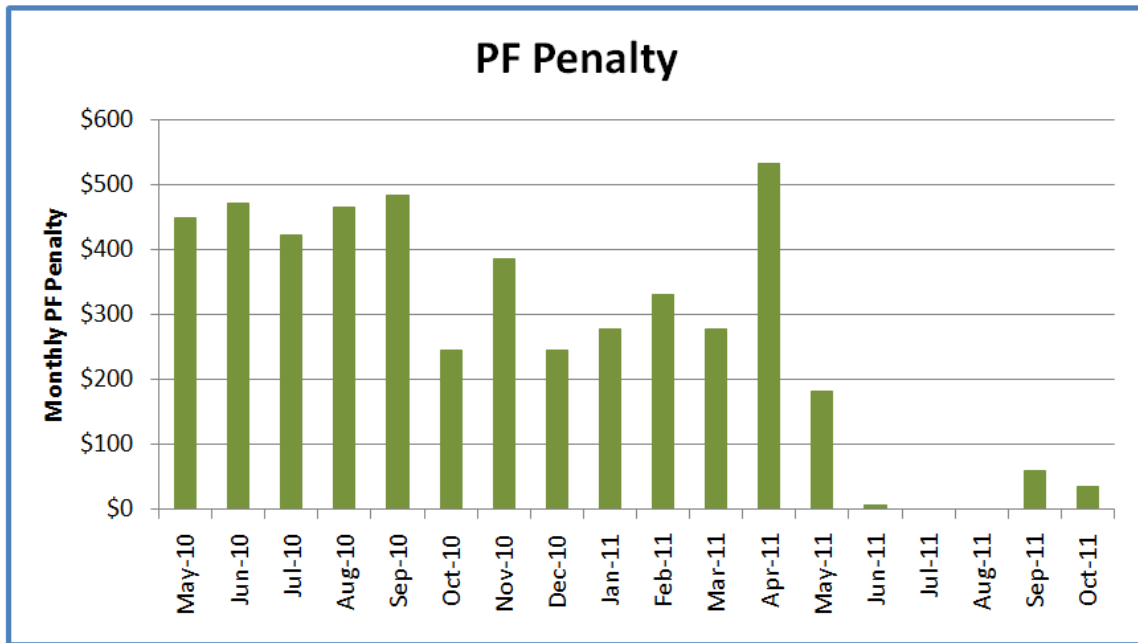
Graph 2: Details the Power Factor Charges from May 2010 to October 2011.

Note: New 250 kVAR Power Factor Correction Unit was activated on May 1, 2011 and for the six(6) months following activation the PF penalty charges is estimated at **\$282** for the period vs. **\$4,581** for the previous 12-months.

The metering interval data provided was based on meter the whole site electrical system. The causes of minor power factor penalties after the installation of new power factor correction system are caused by heavy electrical usage from other buildings connected to site main electrical service, and only during brief periods when MRF processes operations are at peak demand. The slight rise in power factor penalty in September 2011 and October 2011 were contributed to the new 2,500 Amp 600 Volt service for the Compost Plant coming online and the power factor correction system attempting to compensate for the additional load.

If the City of Guelph wishes to further eliminate power factor penalties altogether for the MRF site or if in future Guelph Hydro adopts high power factor penalty thresholds above 0.90 (90%); the City may wish to install additional power factor correction equipment in adjacent buildings to correct whole site power factor conditions. Possible candidate sites is the transfer station and wet waste building(s) which have large exhaust fan motor loads; which are known to cause lowered power factor conditions.
