## **Mixed Broken Glass Clean Up System**

**CIF Project #: 928**

**Prepared By:** Sumantra Datta-Ray, P. Eng  
**Recipient:** Regional Municipality of York  
**Prepared for:** Continuous Improvement Fund  
**Date:** May 2017

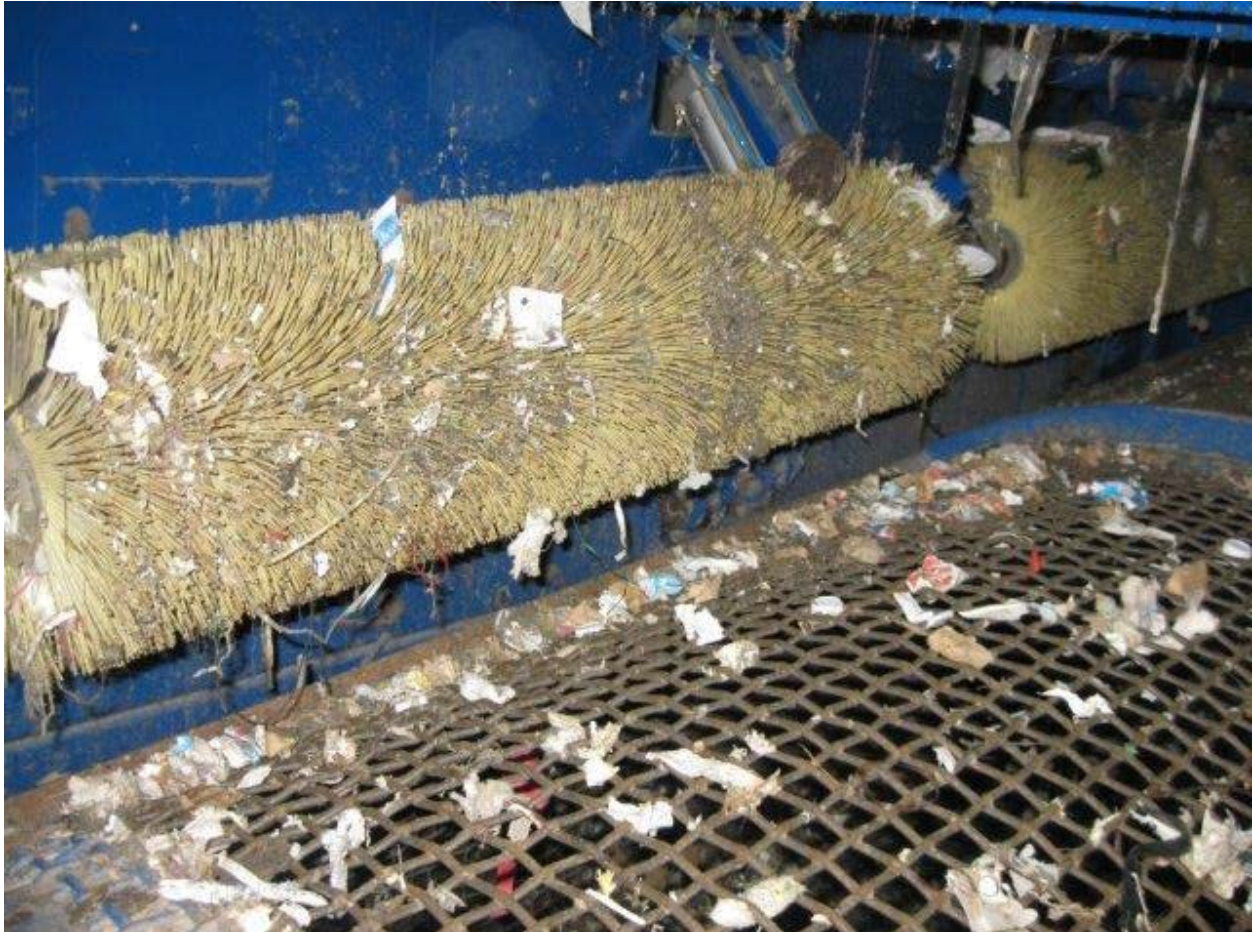
**Figure 2 -Trommel brush**

Miller Waste staff noticed that increased moisture in the feedstock resulted in blinding of the trommel screen. Machinex suggested the addition of hydraulic brushes to scrape the screen as it rotates as seen in Figure 2 below.

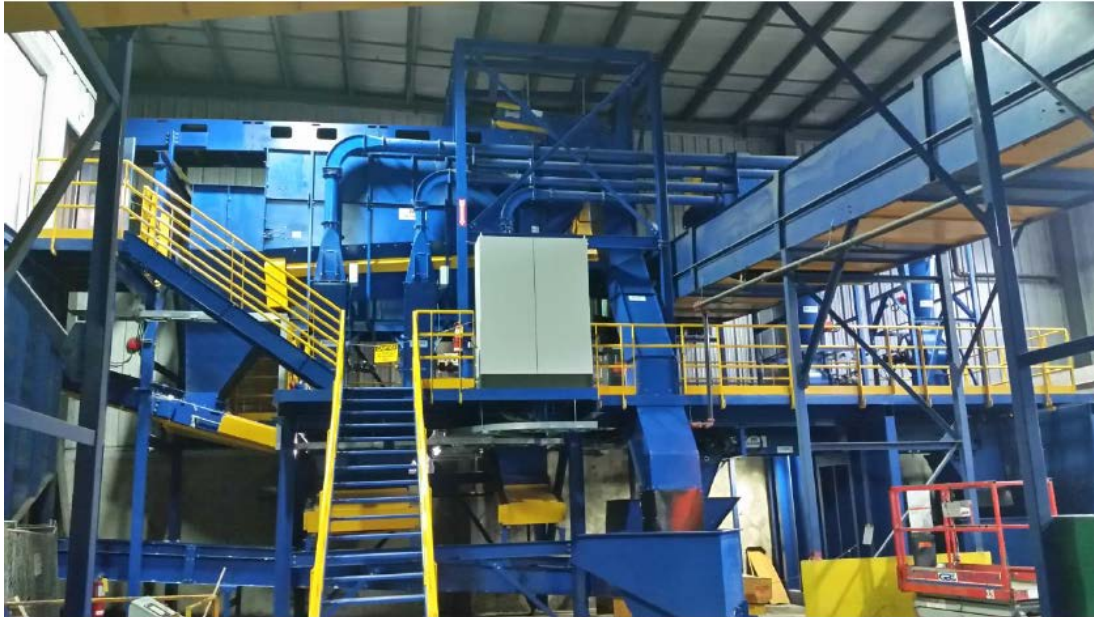
**Figure 3 - Mixed Broken Glass Trommel**

Figure 3 shows the installed trommel screen. The ferrous discharge bin can be seen to the right of the staircase.

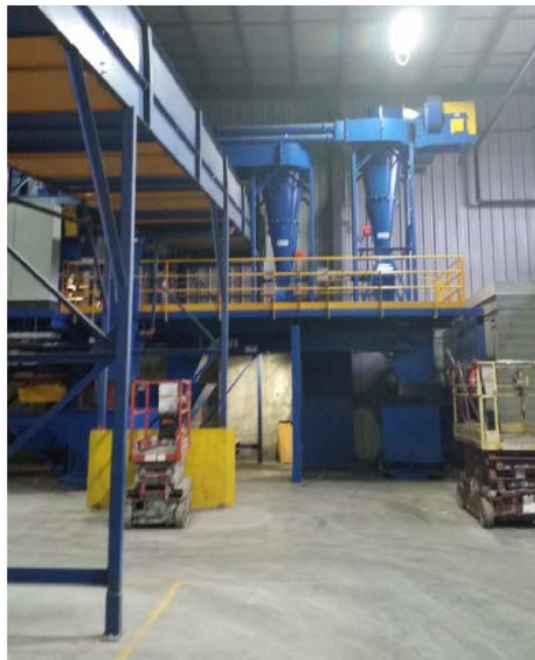
**Figure 4 - Installed cyclones**

Figure 4 shows both cyclones installed with the discharge bin for the cyclone light material beneath it. The conveyor below the cyclone is reversible which allows for the cyclone discharge to either discharge into the bin or be sent to residue.

The reason for the reversible conveyor shown in Figure 4 was in hopes that the light fraction material captured by the cyclone are predominantly fibre and could be added to the paper bales. However, once installed it was observed that this material had high grit content and would not pass quality control for the Region's paper bales. As such, the light fraction from both cyclones was managed as MRF residue.

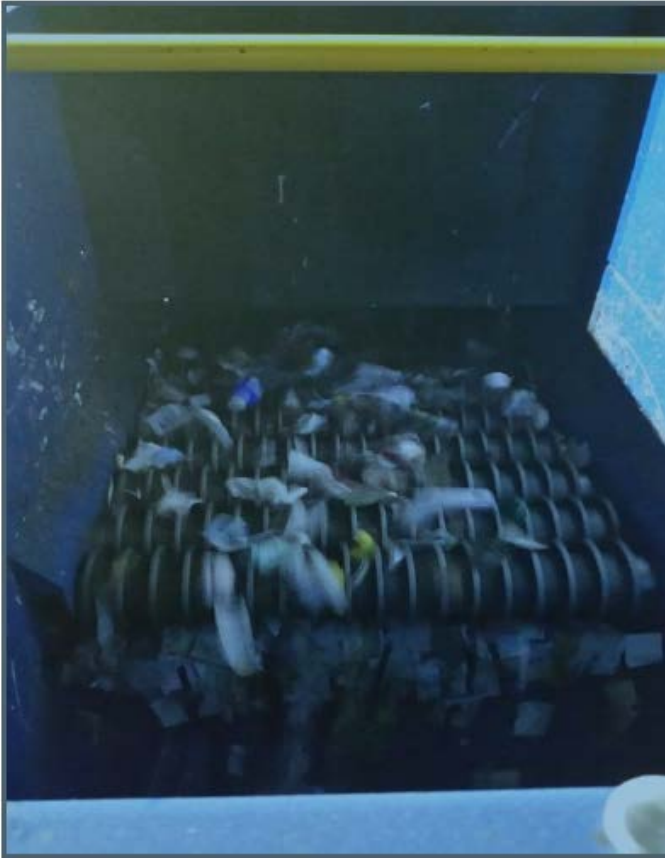
**Figure 5 - Recycle return disc screen**

Figure 5 shows the fines disc screen, which removes fine material (as unders) prior to returning recyclables (via the conveyor shown in Figure 6) to the mixed paper clean up system for further separation.

After the site visit, it was agreed to add a fines disc screen to manage the oversized fraction coming out of the trommel screen. The fines disc screen would remove any small fractions (mainly 1  $\frac{1}{2}$ " minus) that can still be in the stream. The 1  $\frac{1}{2}$ " minus fraction would be re-directed to the light material removed by the rotary separators for disposal as residue while the remaining fraction is conveyed to the mixed paper clean up system for further separation.
