# Auld Road Transfer Site Solar Compactor Retrofit

## CIF Project 830.3

Township of Whitestone 21 Church Street Dunchurch, Ontario POA 1G0

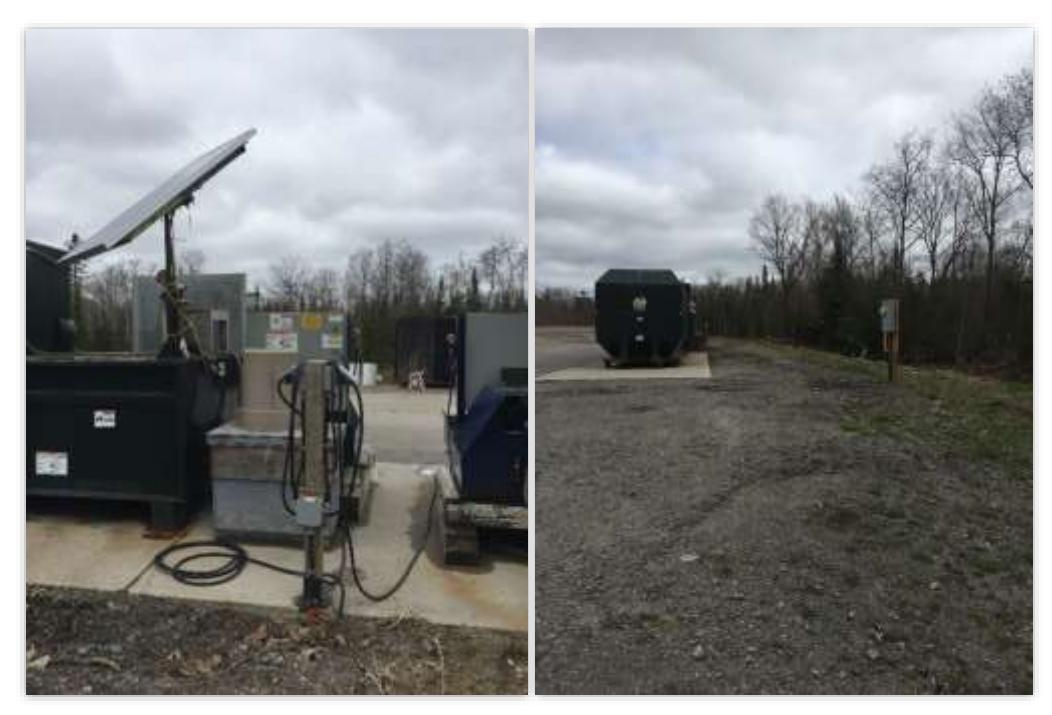
Minor site improvements were completed at the Auld Road waste transfer site during the month of November, 2015 to facilitate the implementation of the connection to the hydro grid. As pictured below, modifications to the concrete pad, including setting a post to attach electrical equipment to and a second post for the metre. This work was completed by municipal staff and involved the rental of some equipment. No issues were noted in completing the work.

Figure 1: Photograph of electrical site upgrades

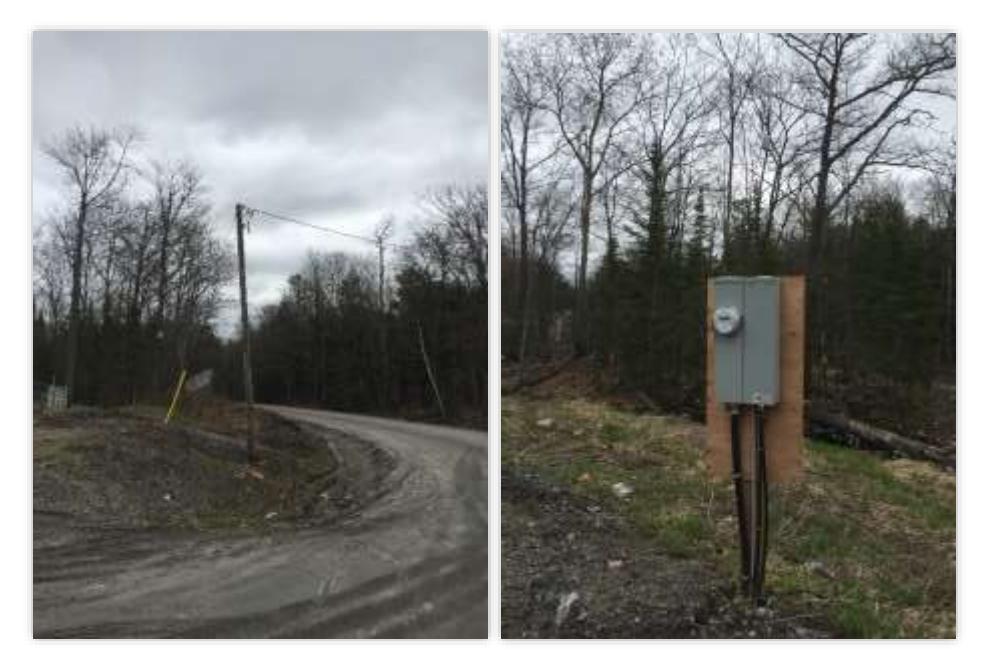
BRS Electric Ltd. was contracted in February of 2016 to install a pole mount 200A outdoor service, conductors, and the requisite cabling and installation of electrical receptacles at the compaction units. Hydro one was contracted to connect the site equipment to the grid. The 30A electrical receptacles are featured in the left picture on the preceding page, while the pole mounted service equipment is pictured below. The work was completed over two days and without issue. Service hours for the public were not impacted.

Figure 2: Photograph of hydro grid connection and metre

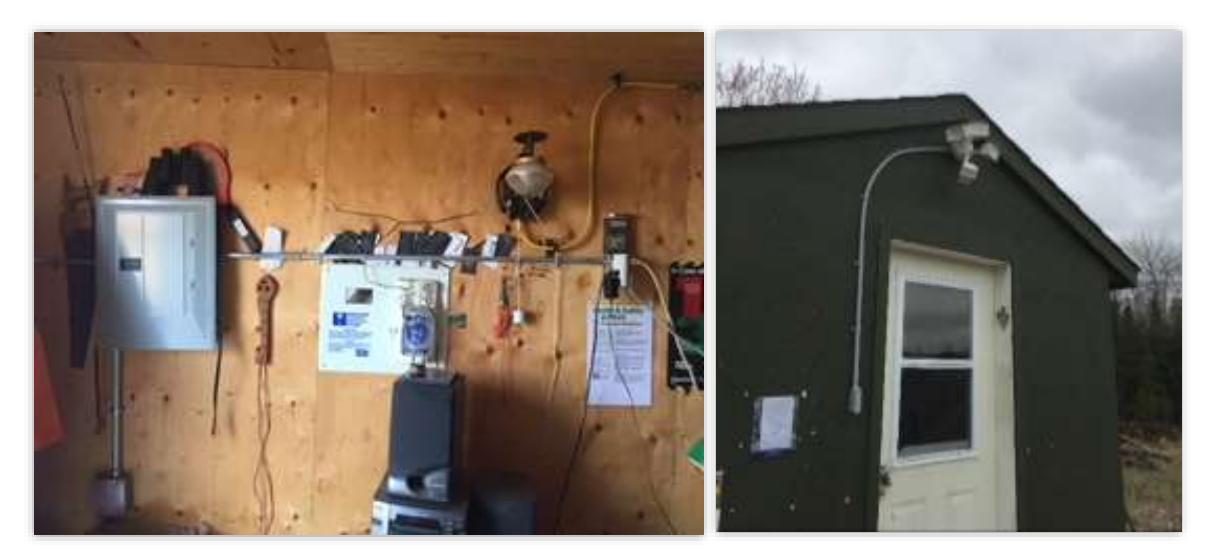
Figure 3: Spotter shack electrical improvements

Municipal waste site staff are pleased with the improved safety of the work site attributable to the new lighting system both inside and outside the spotter's shack.
