Subject: Recycling Contamination Study Summary of Findings

The following is a summary of the findings of the curbside recycling contamination collection study undertaken in Barrie on September 26 and October 11, 2017. The purpose of the study was to evaluate the effects of instructing curbside collection drivers to put more time and effort into hand sorting contamination from single family residential blue boxes.

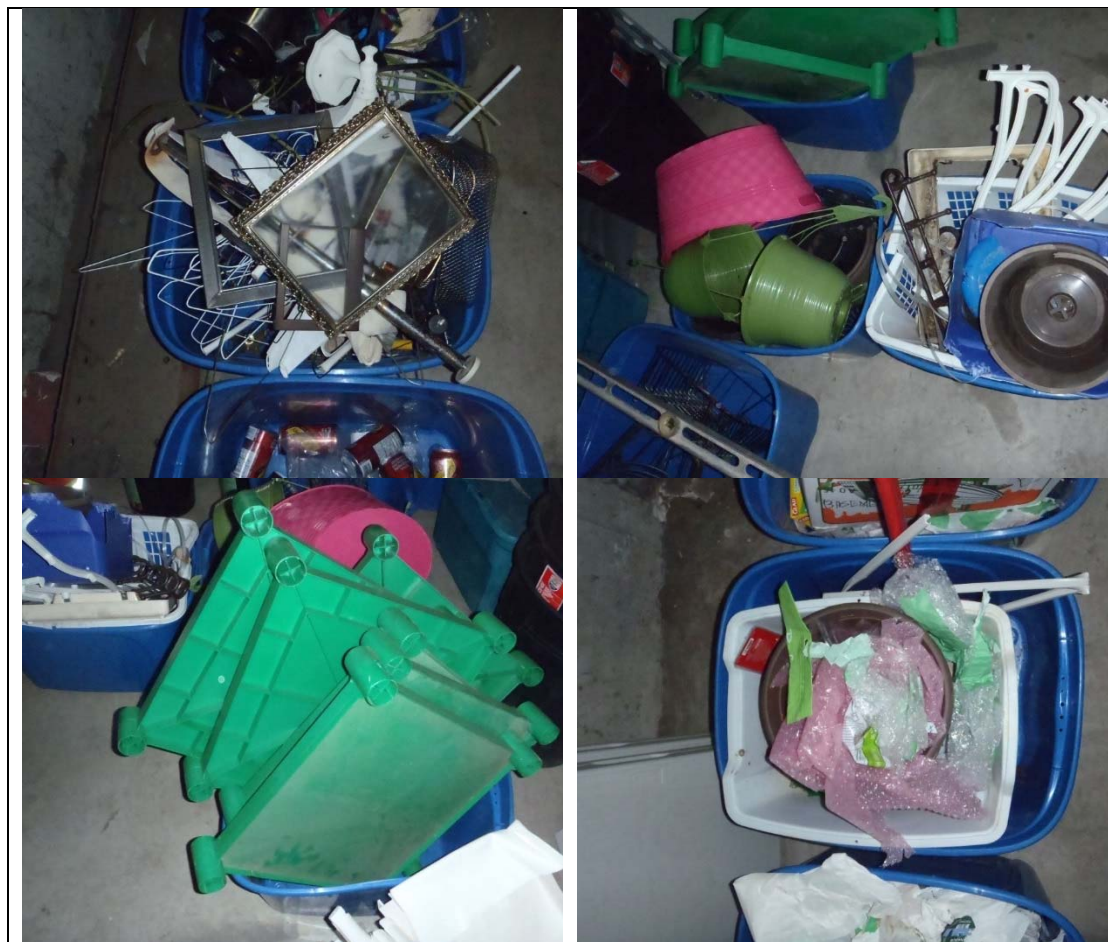
During week 1 of the study, in which the collection driver was instructed to complete his route as usual (i.e. do not sort out any more or less at the curb than usual), the average time per stop was 19.11 seconds. Overall contamination rate of the material that ended up in the truck (fibres & containers stream combined) was 9.3%. The driver left behind 250 kg of material at the curbside from 52 households. This included larger individual items that were obviously contamination (e.g. vacuum, glass table top, large pails, plant pots), and full rejected boxed (obvious contamination mixed in throughout the box). The following photos show examples of common contaminants left at the curbside by the driver under normal operating conditions.

Examples of Material Left at Curbside in Baseline Week 1

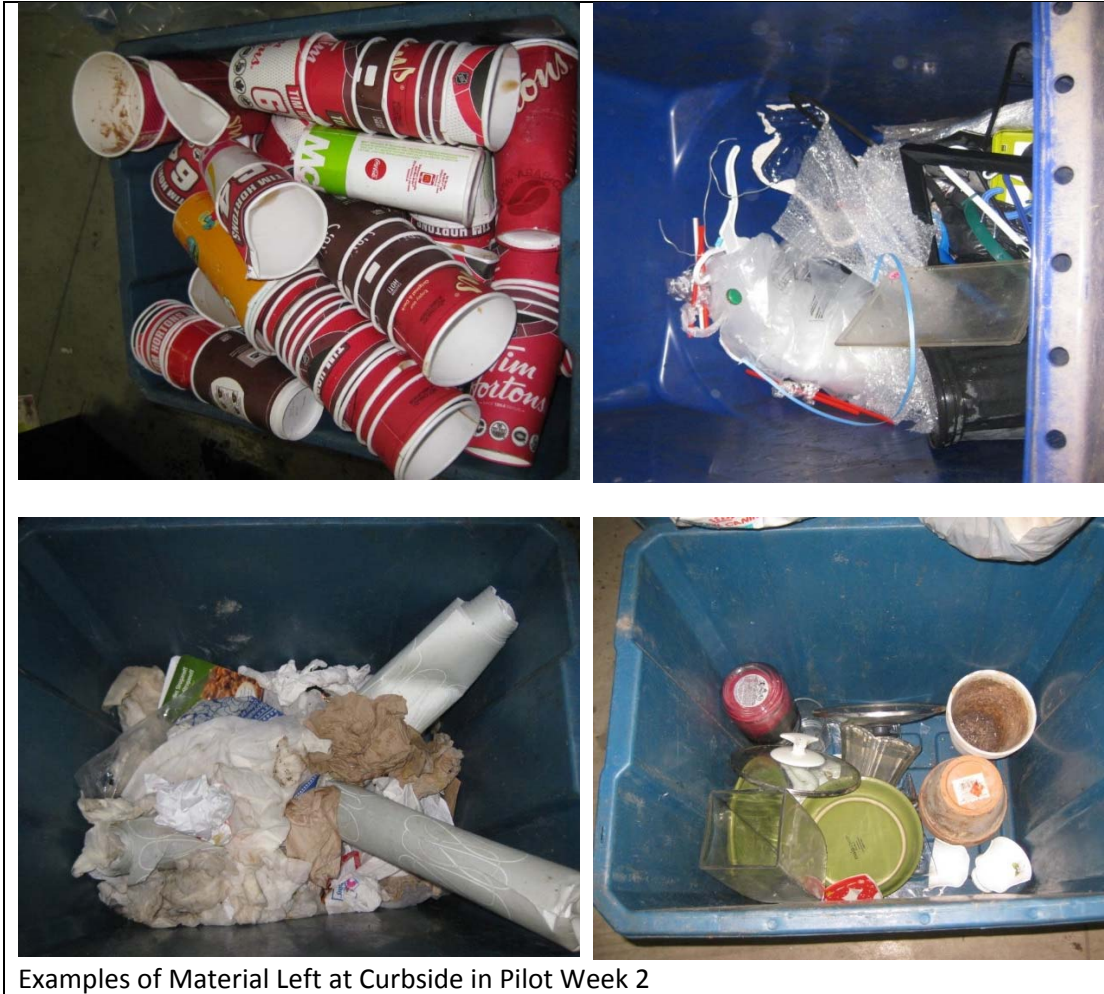
During week 2 of the study, in which the collection driver was instructed to take extra time at the curbside to sort out contaminants, before tipping into his truck; the average time per stop increased to 53.38 seconds. As a result of this additional time per stop, the driver was unable to complete the full route within his regular working hours (additional trucks were called in to help completed the rest of the route). Only material from the portion of the route that the original driver was able to complete was included in the study. Overall contamination rate of the material that ended up in the truck was 5.2%. The driver left behind 336 kg of material at the curbside from 354 households. Again, this included larger individual items that were obvious contamination, full rejected boxes which had significant contamination mixed in, as well as a lot more smaller contaminant items (e.g. coffee cups).

The following photos show examples of common contaminants left at the curbside by the driver under instruction to take more time to sort out contaminants at the curb (Week 2).

Examples of Material Left at Curbside in Pilot Week 2
